# Earthquake Damage to Building Foundations

T. Leslie Youd

Short course on Evaluation of Liquefaction  
Hazard for Engineering Practice

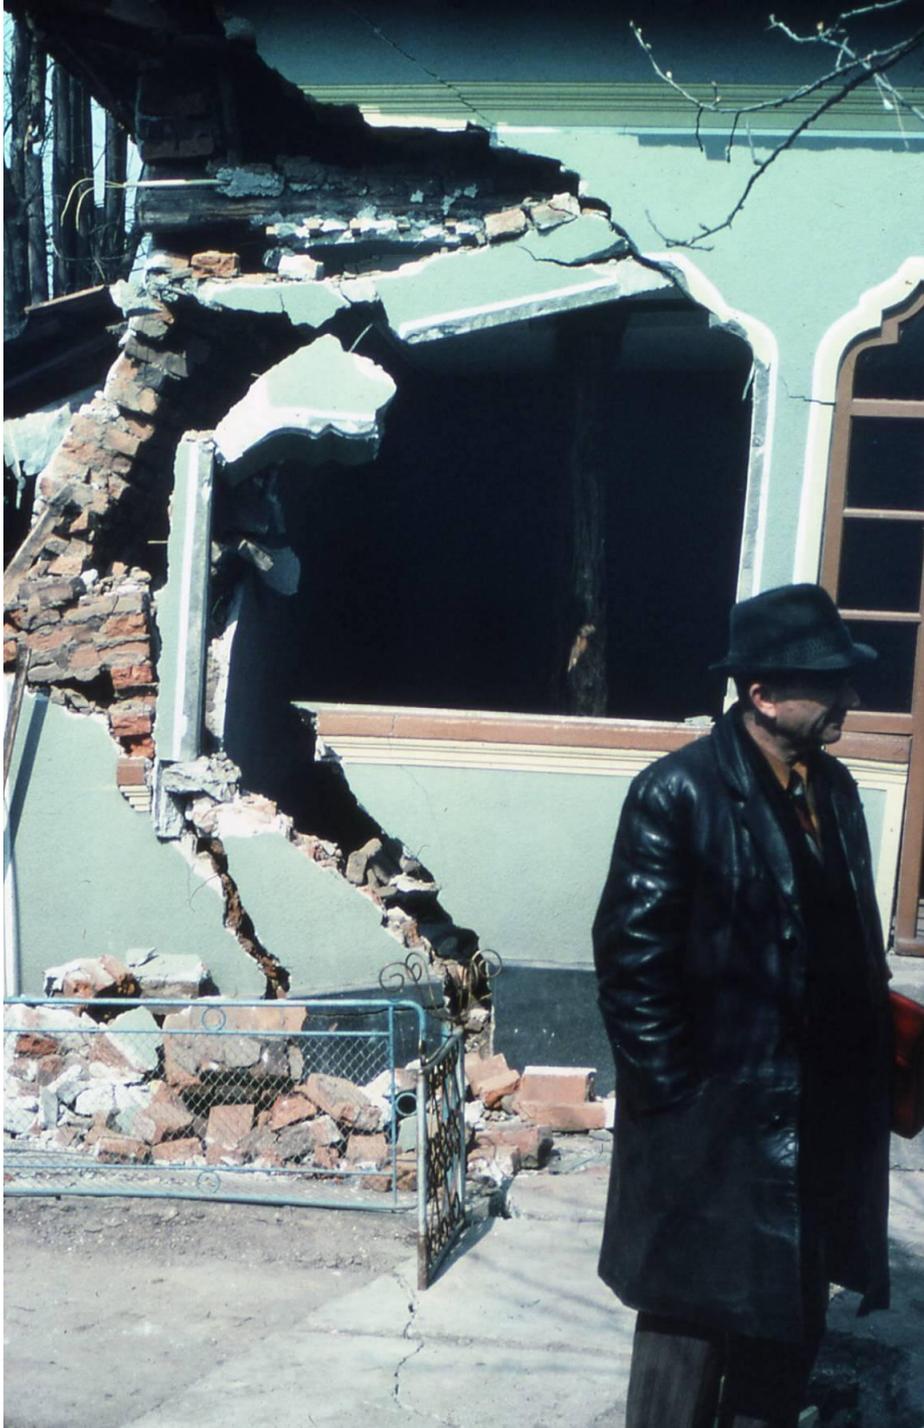
House pulled apart at the foundation level by lateral spread; 977 Varancia, Romania earthquake (Lloyd Cluff Photo)

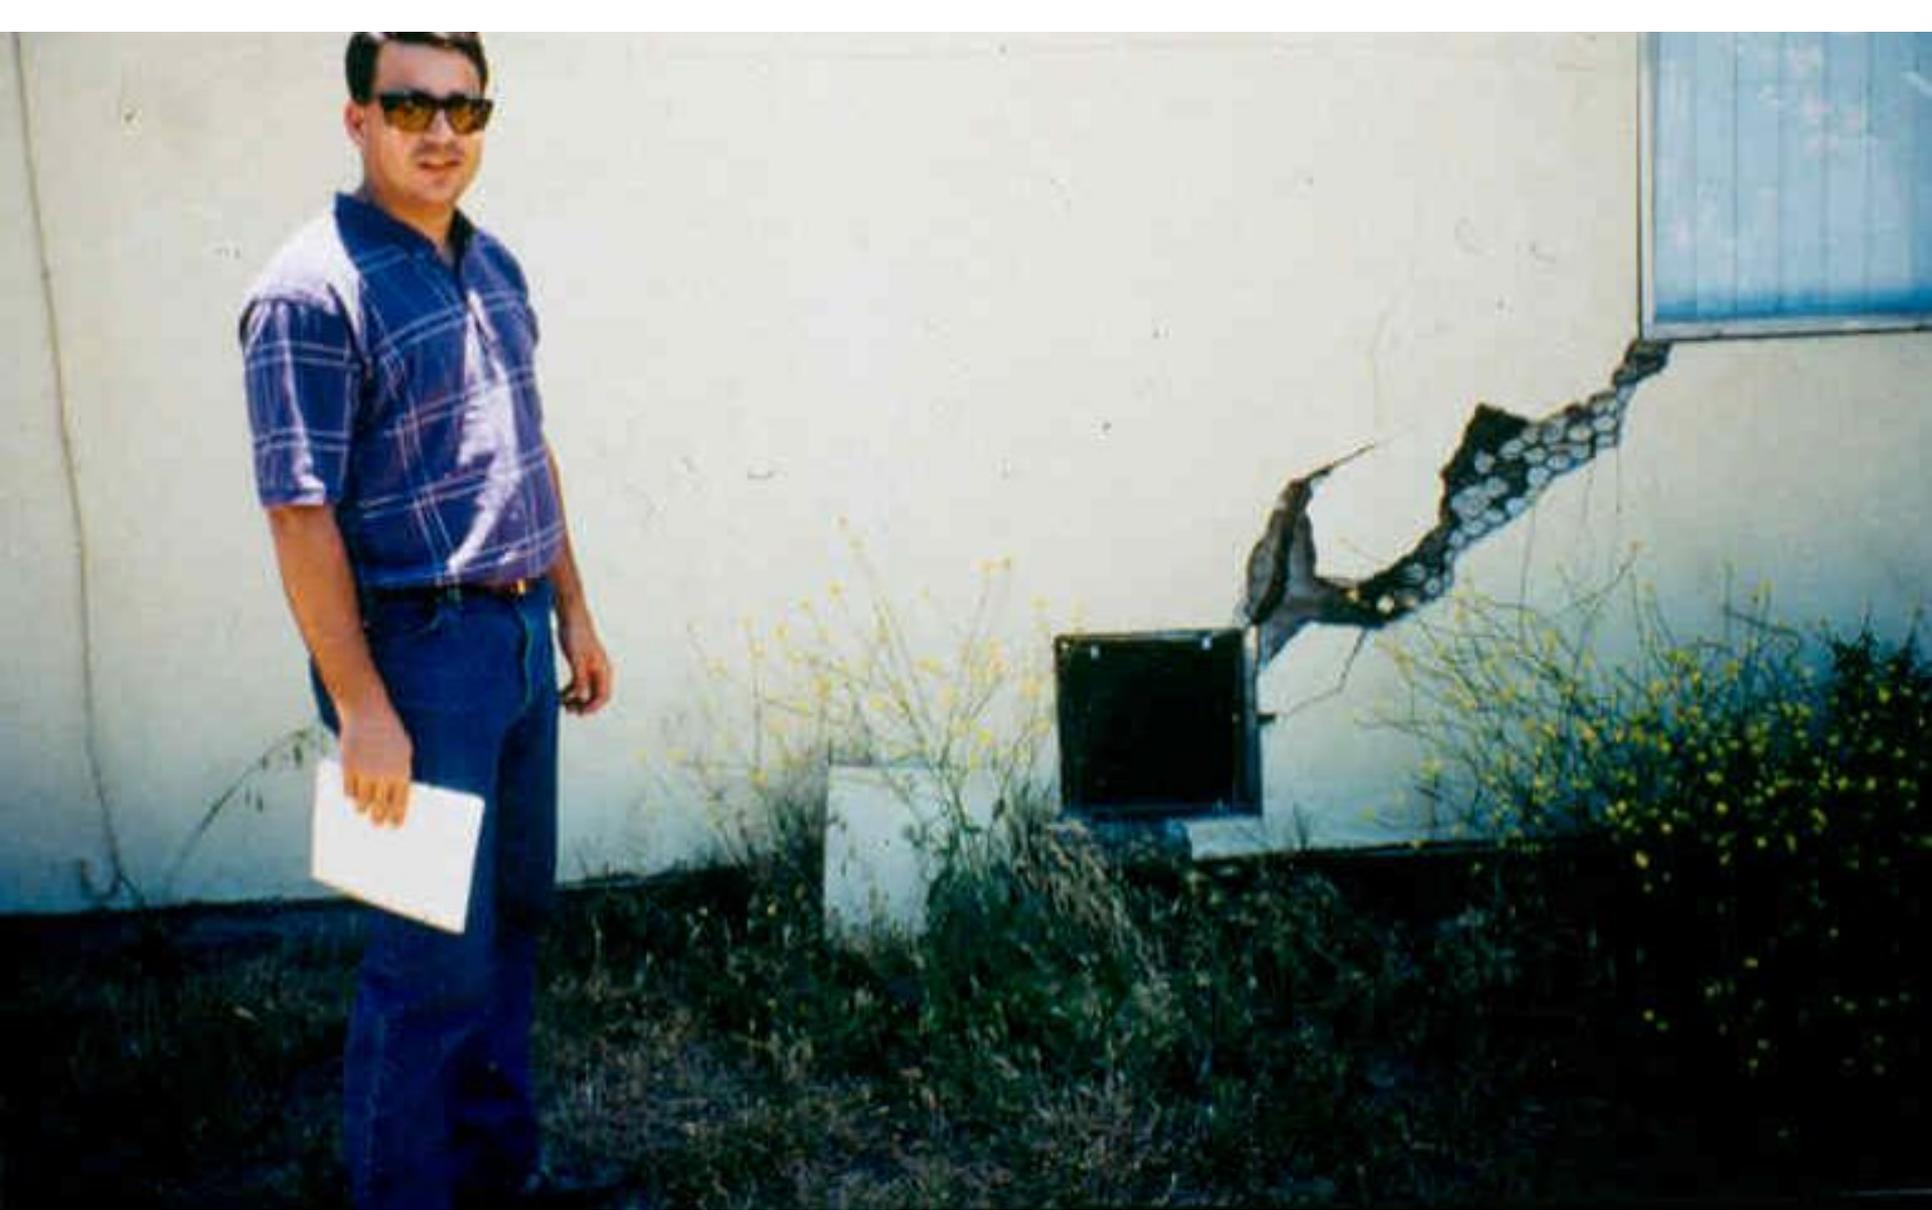
House in Sylmar, California that pulled apart by lateral spread during 1995 Northridge earthquake (Les Youd Photo)

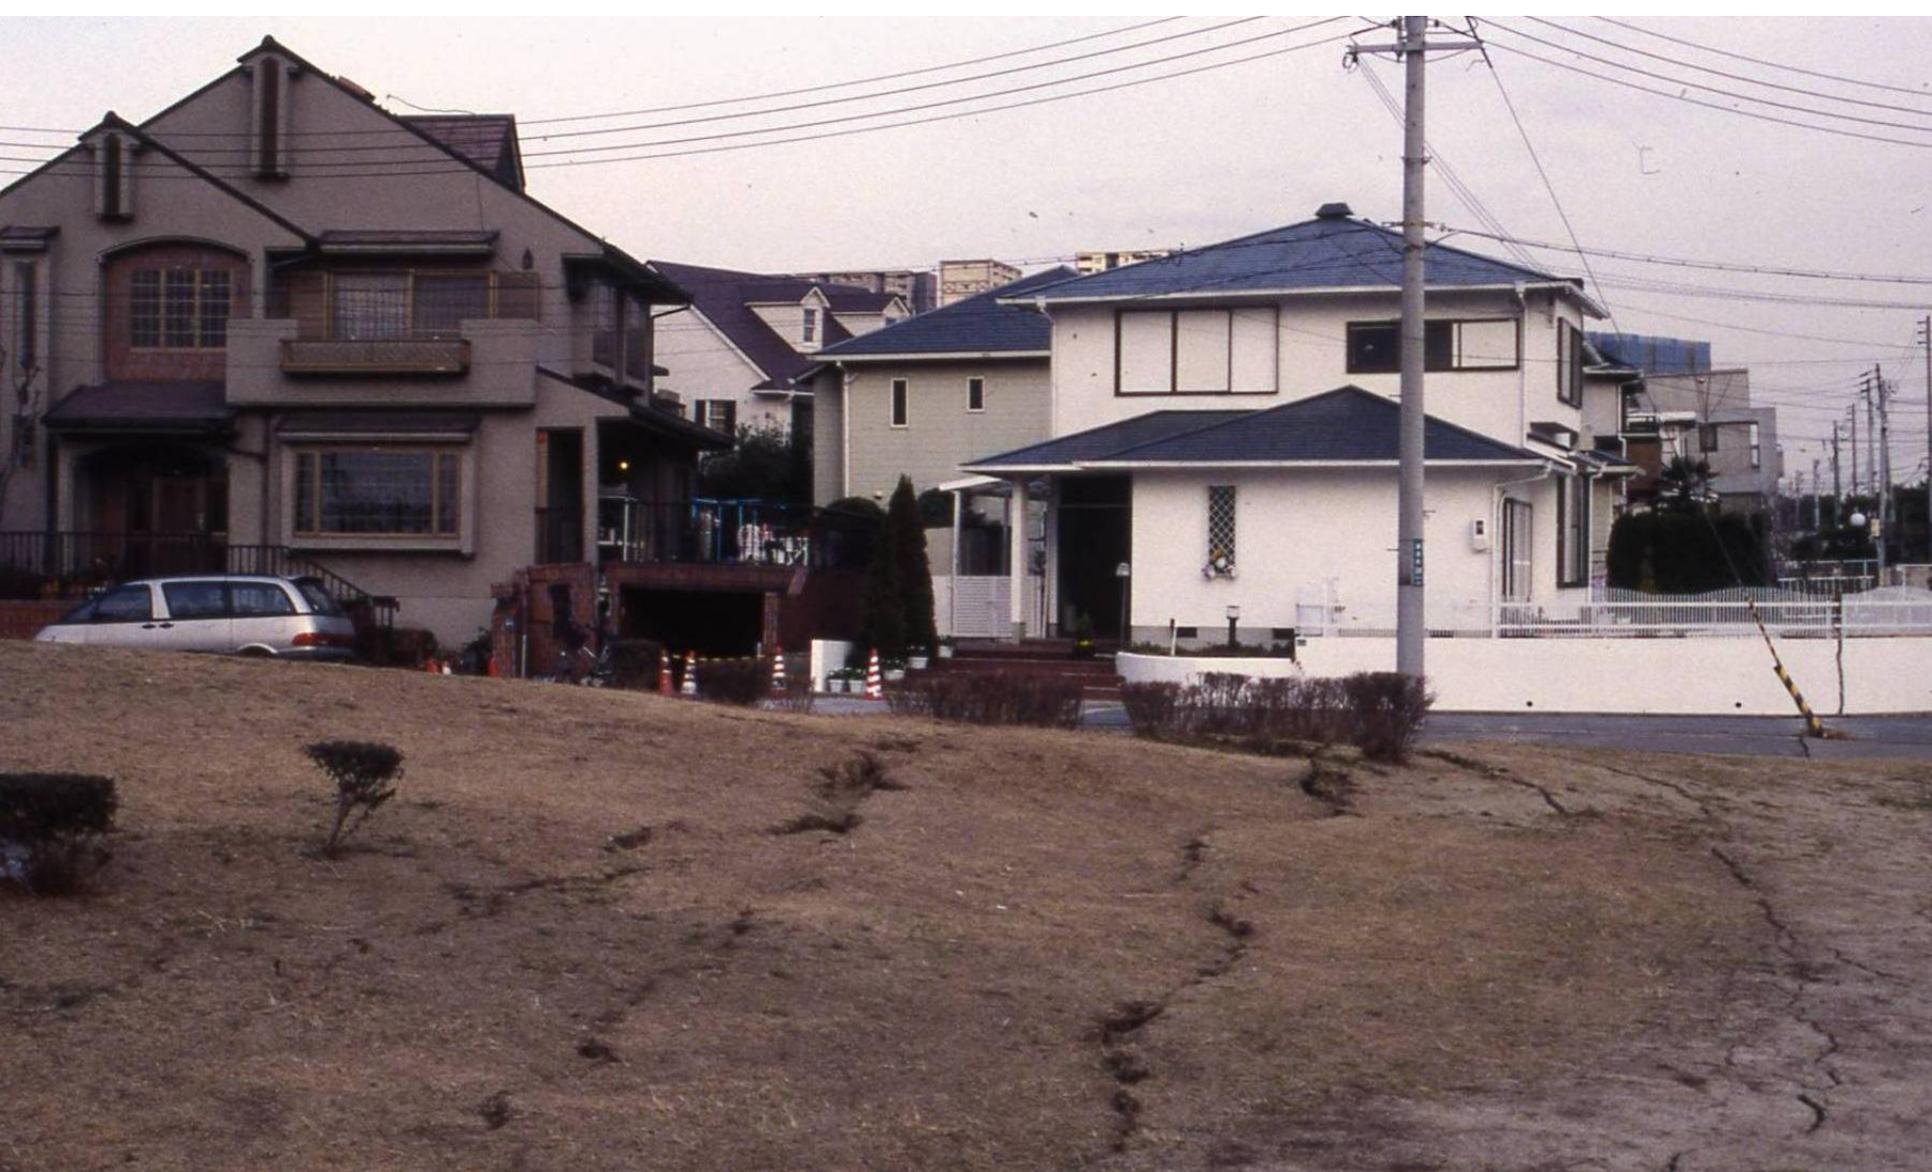
Liquefaction-generated lateral spread fissures during 1995 Kobe, Japan earthquake; the fissures pass beneath houses but caused no damage (Photo by Nick Sitar)

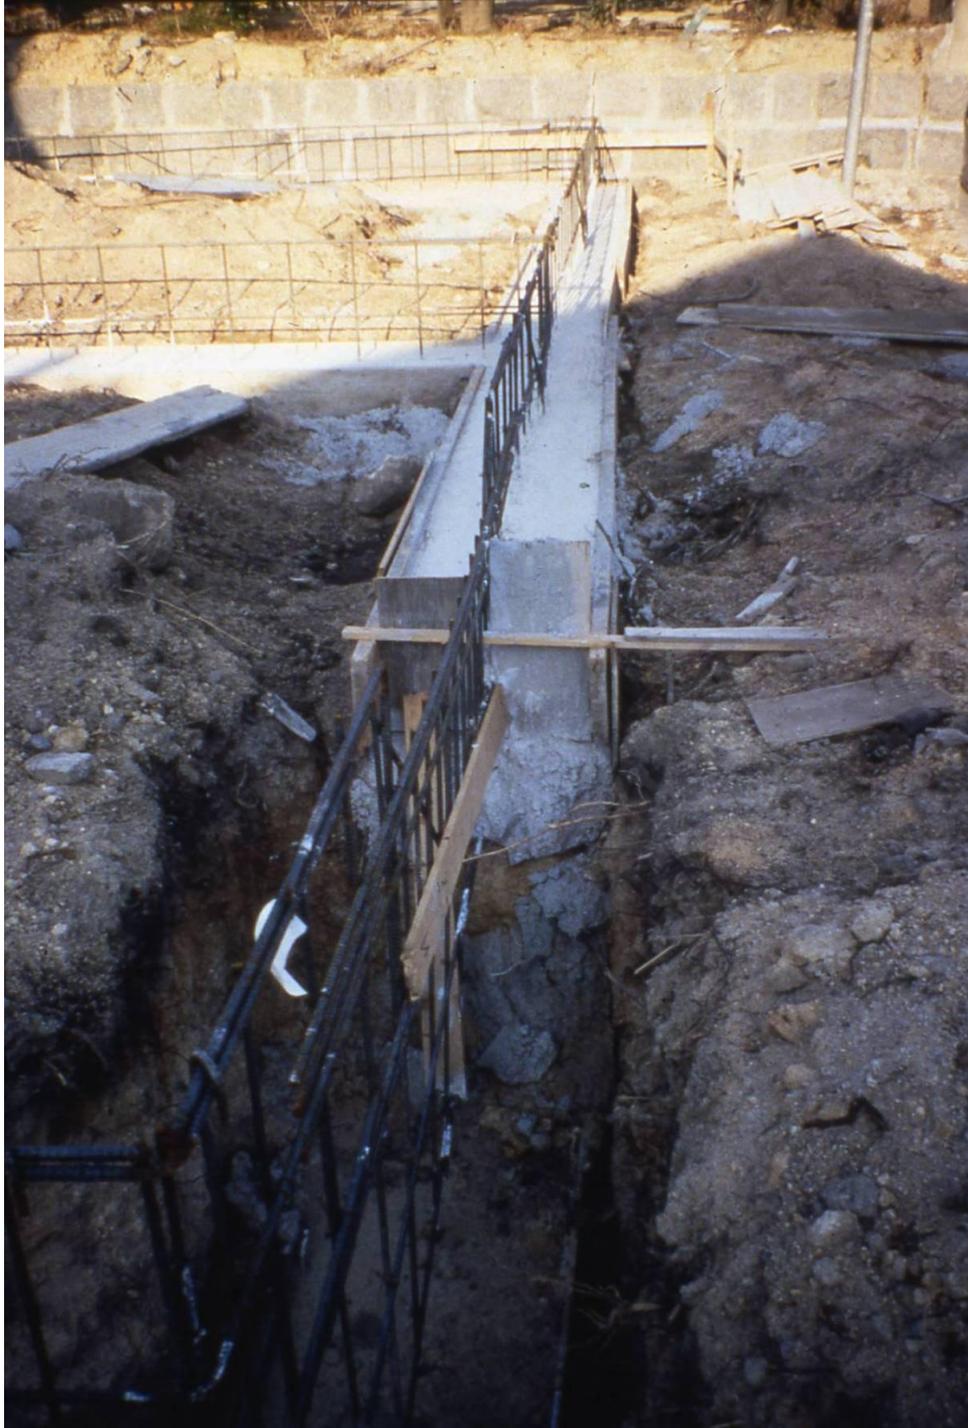
Foundation in Kobe, Japan under construction at the time of the 1995 Kobe earthquake; perimeter foundation is well reinforced with grade beams across the interior, creating a strong diaphragm that is capable of withstanding lateral spread displacement without fracture (Les Youd photo)

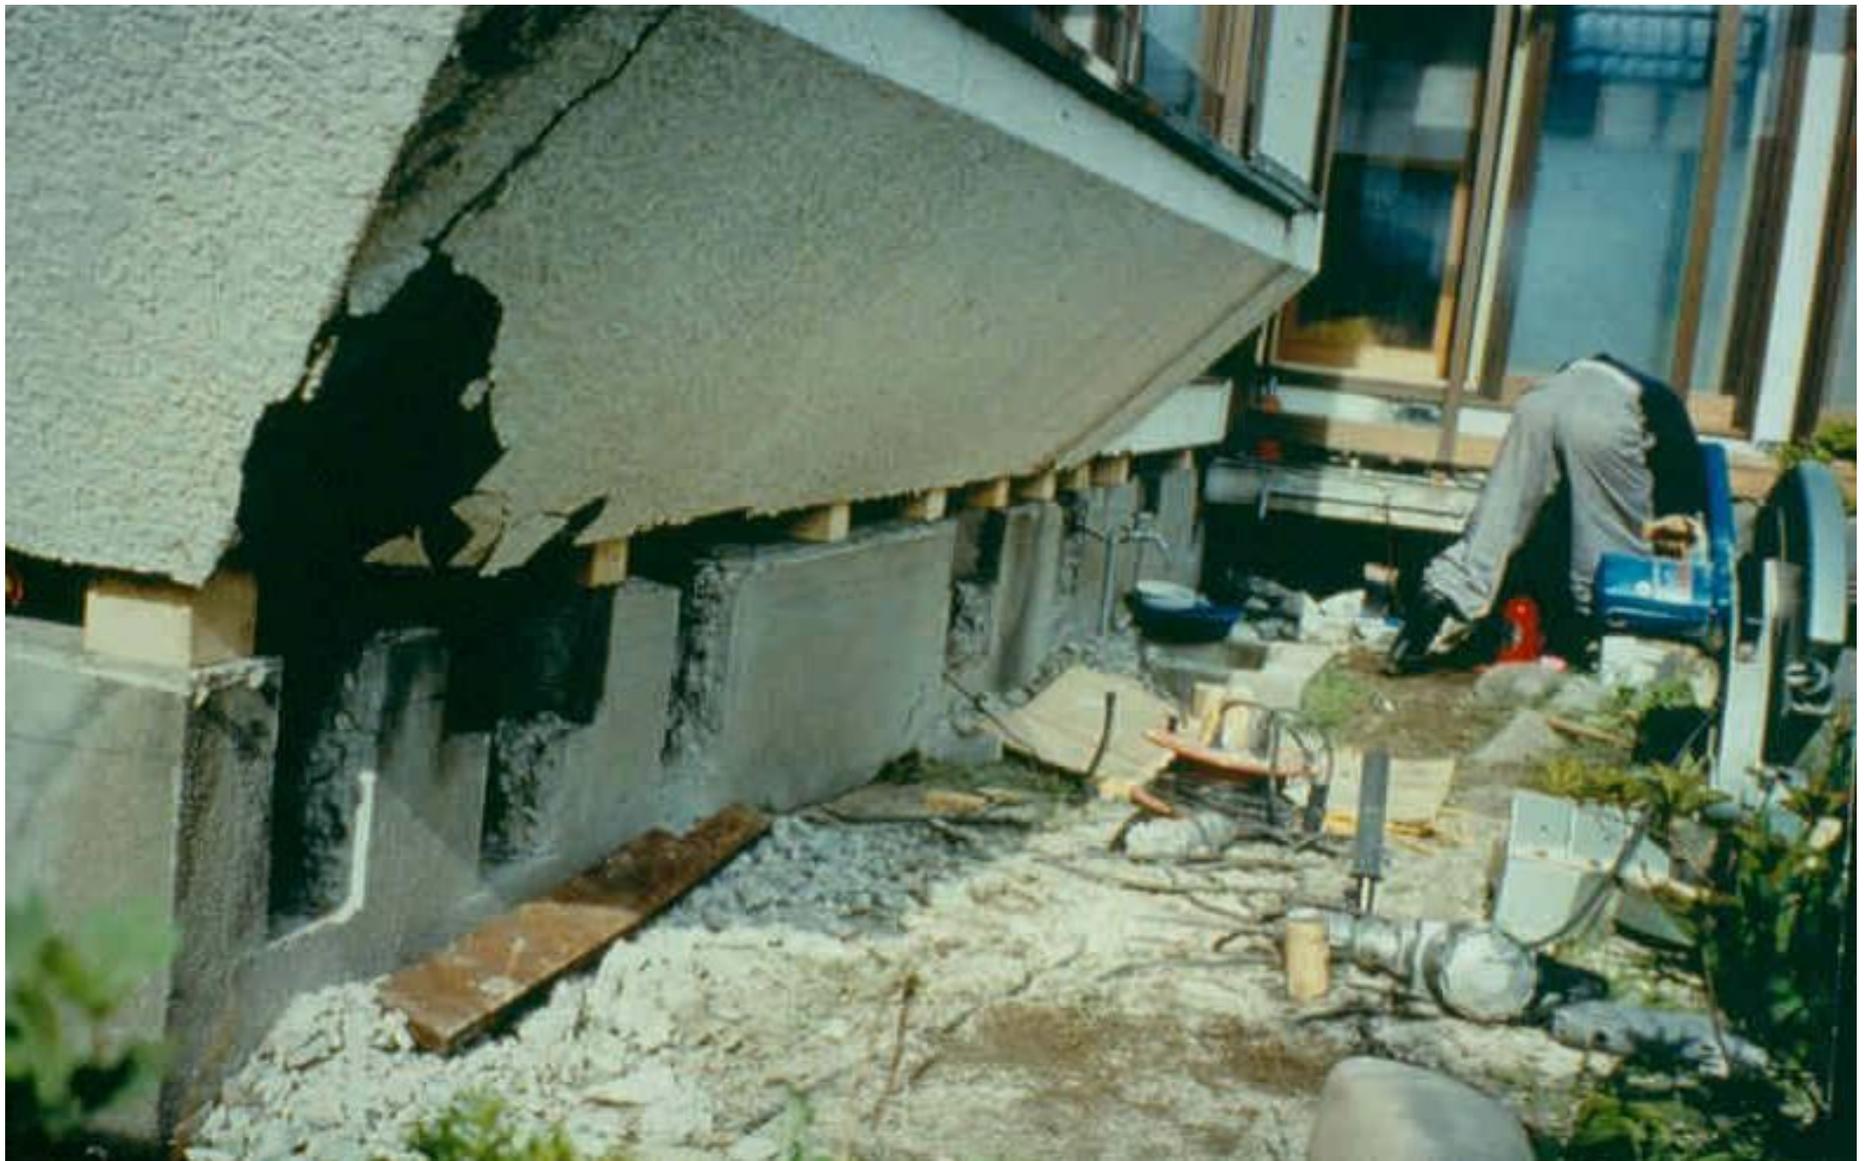
House in liquefaction and lateral spread zone that tilted, but was undamaged structurally during 1993 Hokkaido, Japan earthquake; house undergoing re-leveling (Les Youd Photo)

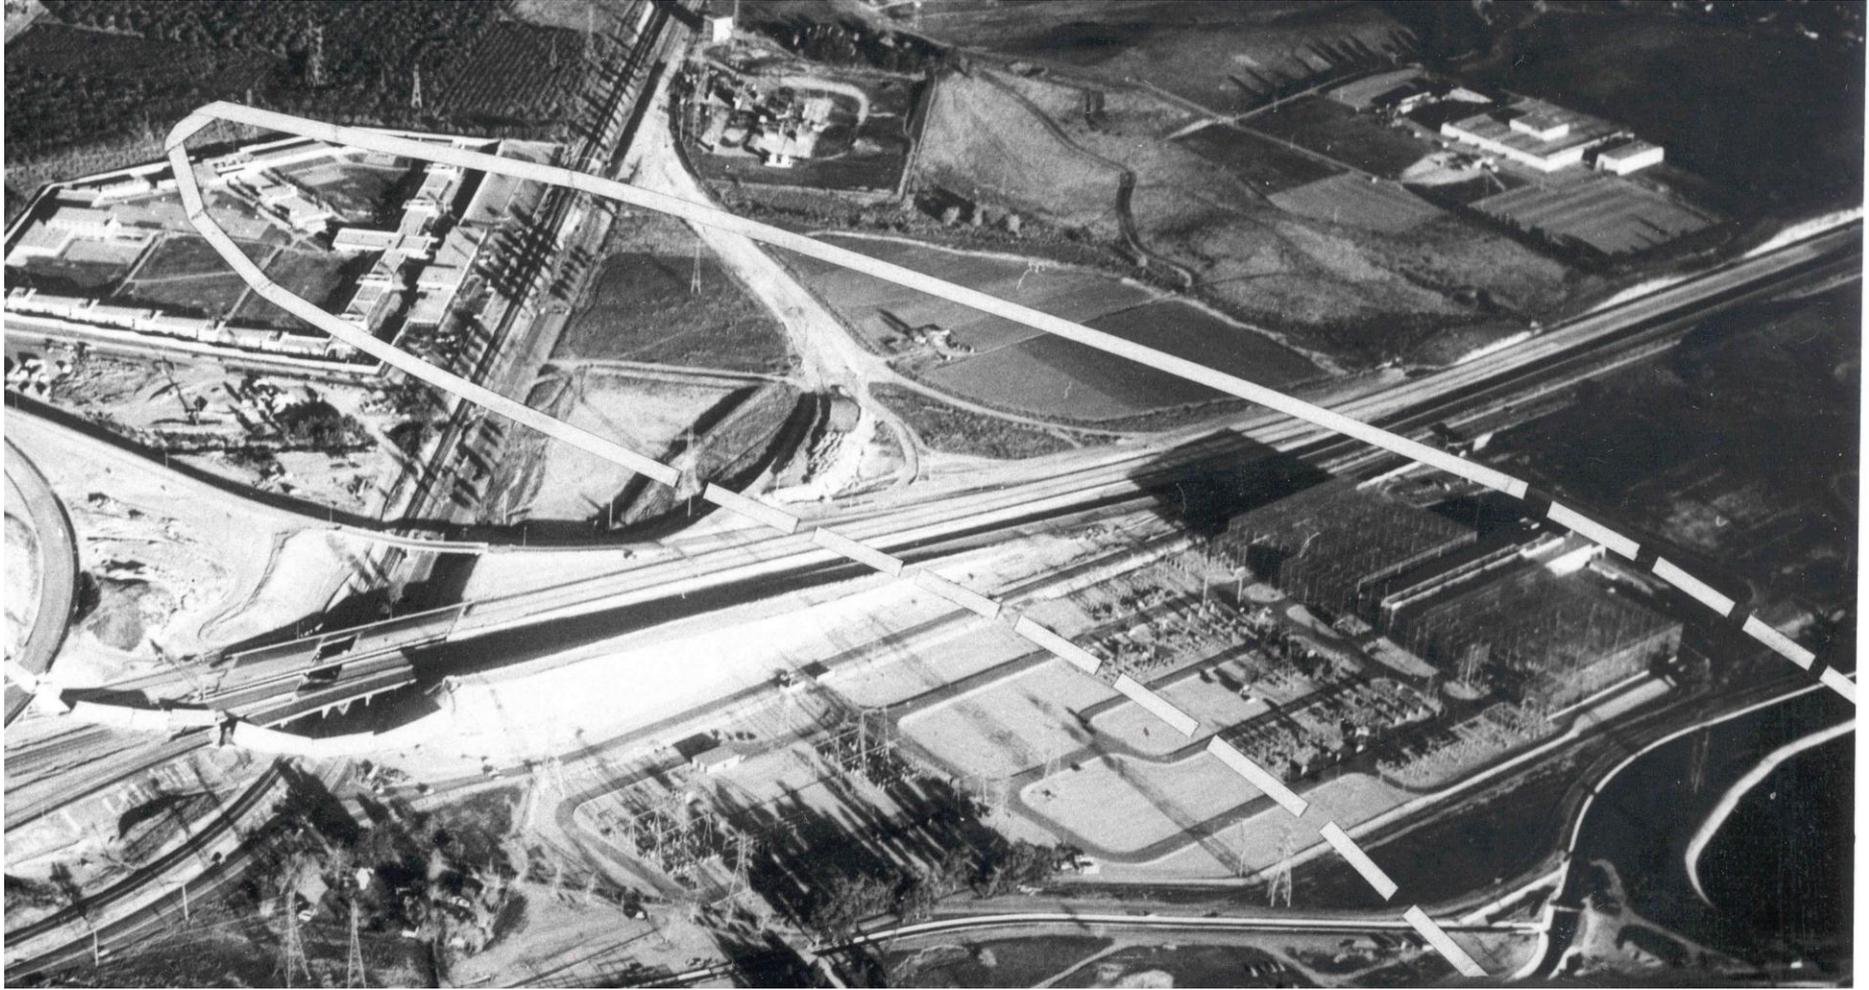
Aerial View of San Fernando Juvenile Hall Lateral Spread Area;  
1971 San Fernando, Calif. Earthquake (USGS photo)

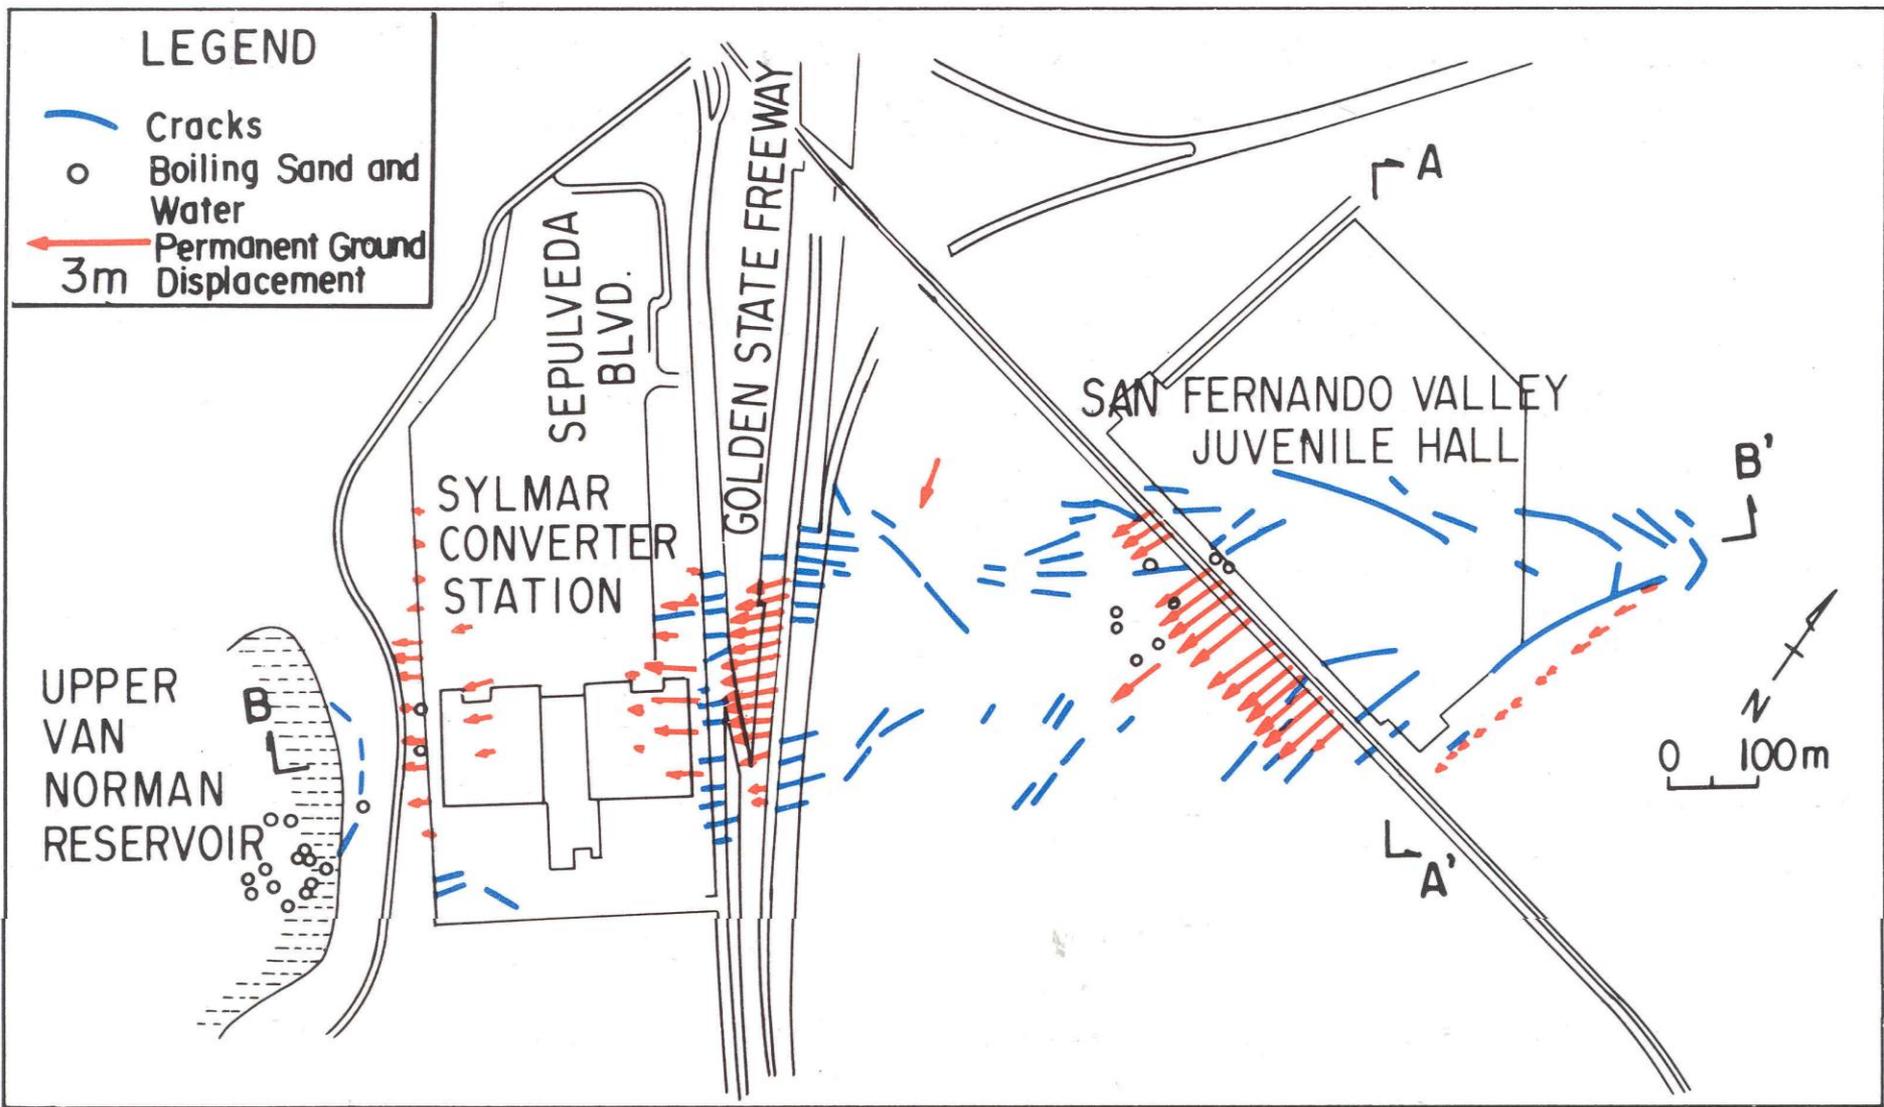
Fissures and Ground Displacements Generated by the San Fernando Juvenile Hall Lateral Spread; 1971 San Fernando, Calif. Earthquake (Youd, 1973, NOAA )

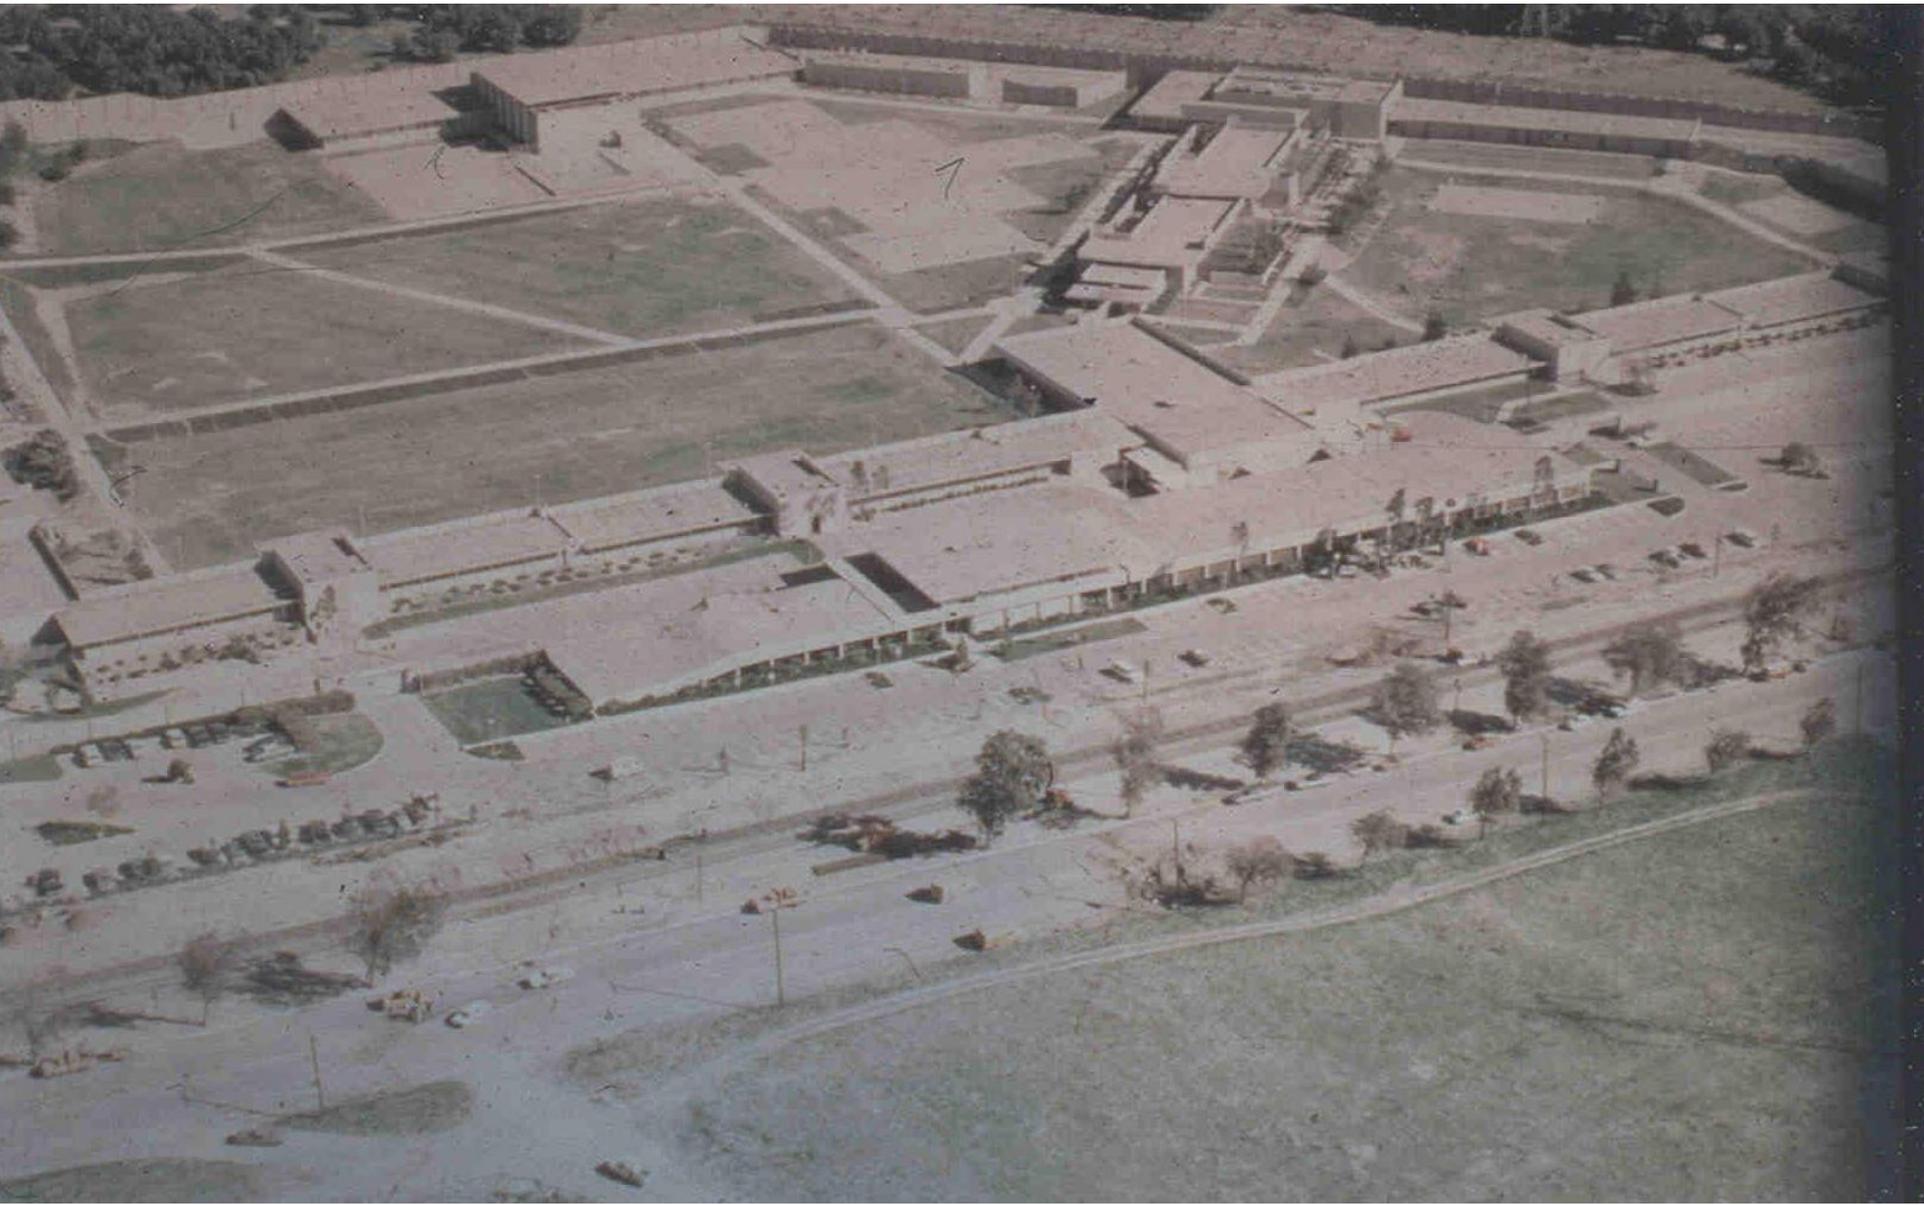
San Fernando Valley Juvenile Hall damaged by lateral spread during 1971 San Fernando, California earthquake (Art Keene Photo)

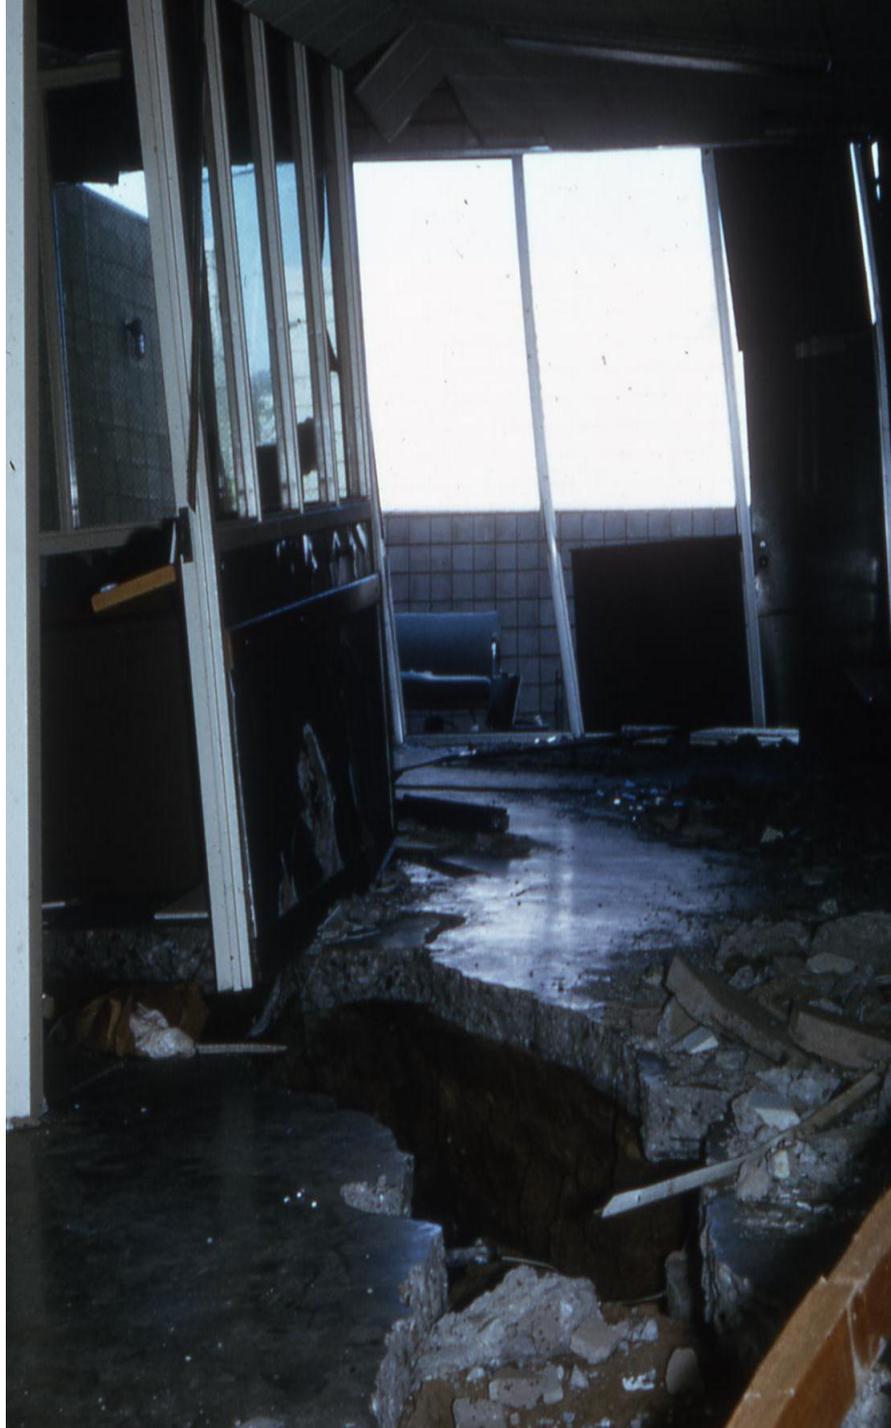
Building at San Fernando  
Valley Juvenile Hall pulled  
apart by lateral spread  
during 1971 San Fernando,  
California earthquake  
(Les Youd photo)

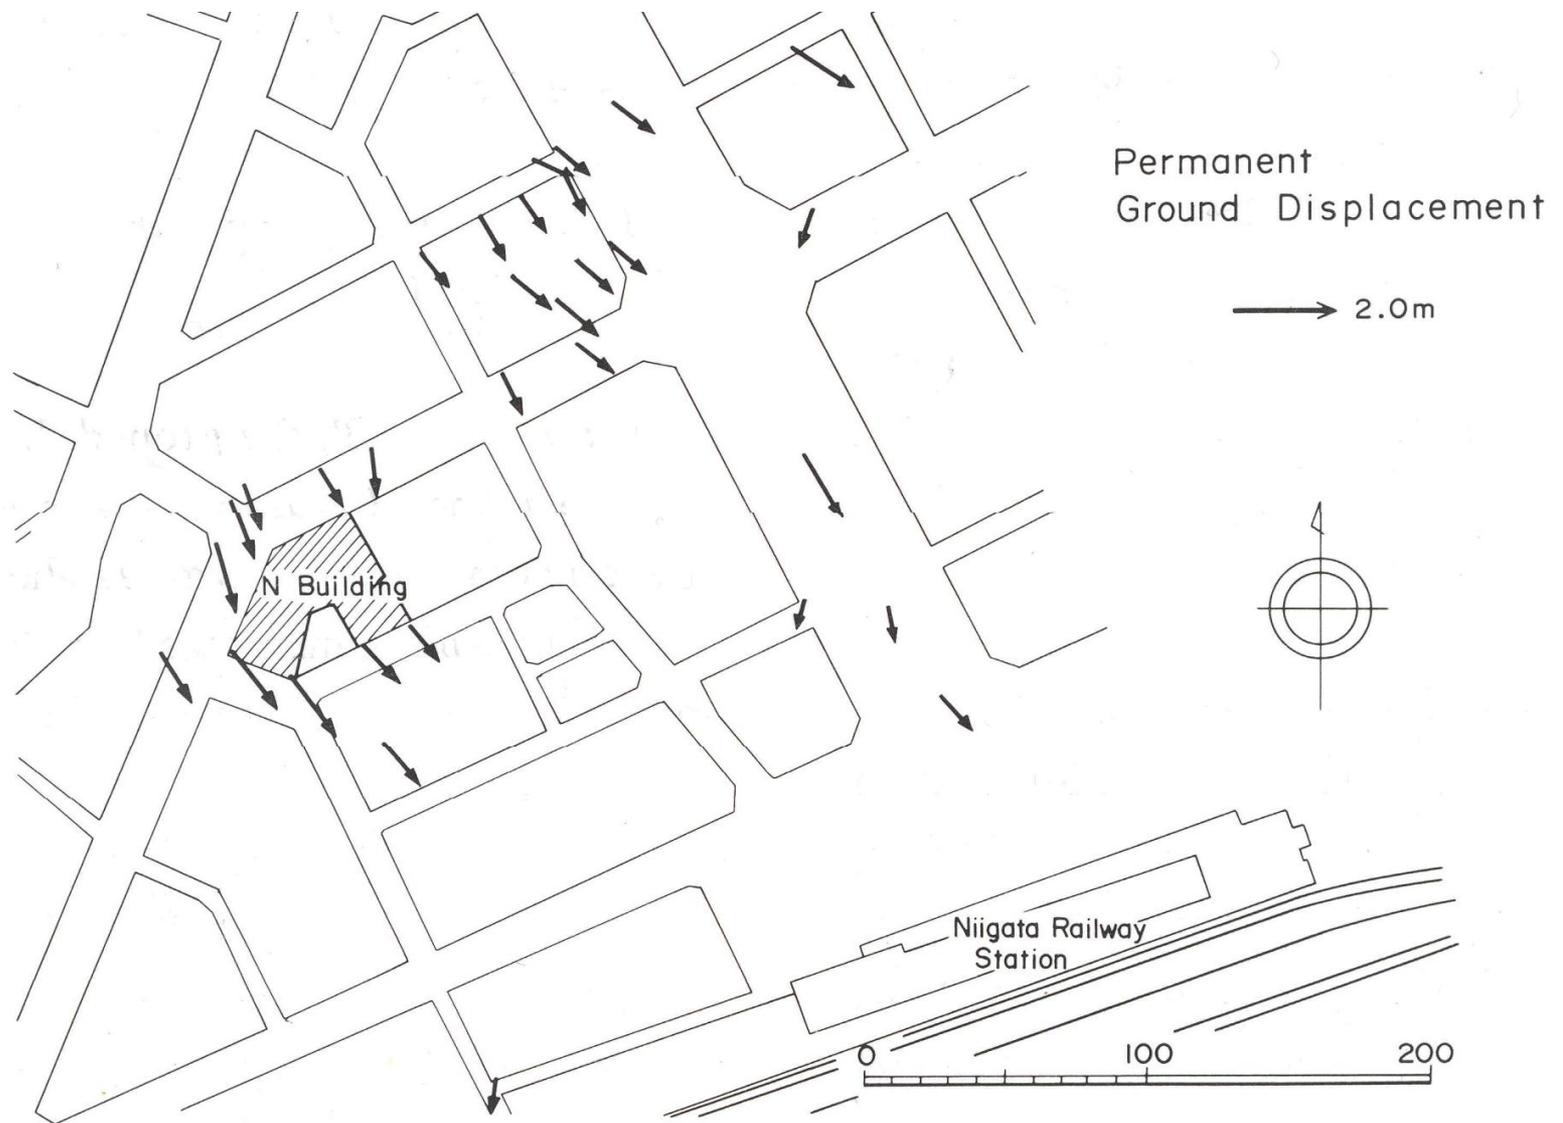
Measured lateral spread displacements around N Building following the 1964 Niigata, Japan earthquake (Hamada, et al, 1986)

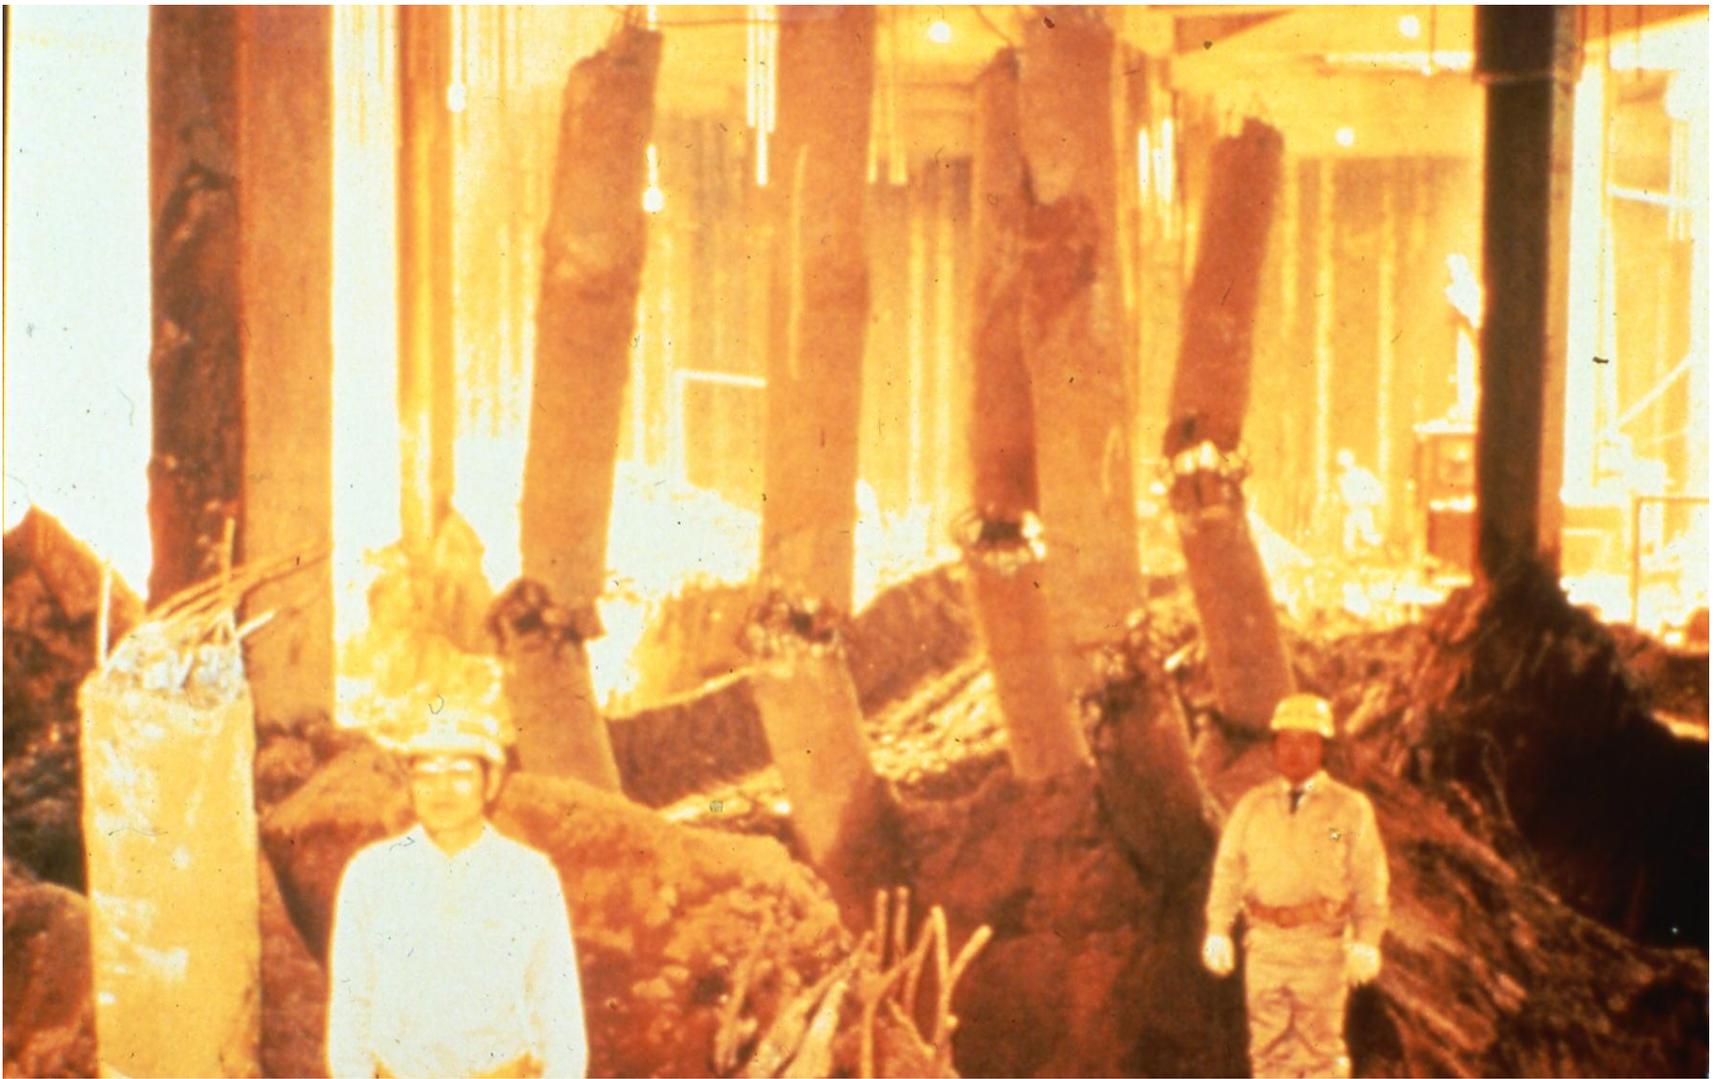
Fractured Piles Beneath N Building exposed during excavation for a new building in 1985; damage to piles caused by Lateral Spread during 1964 Niigata, Japan Earthquake (Japanese contractor photo)

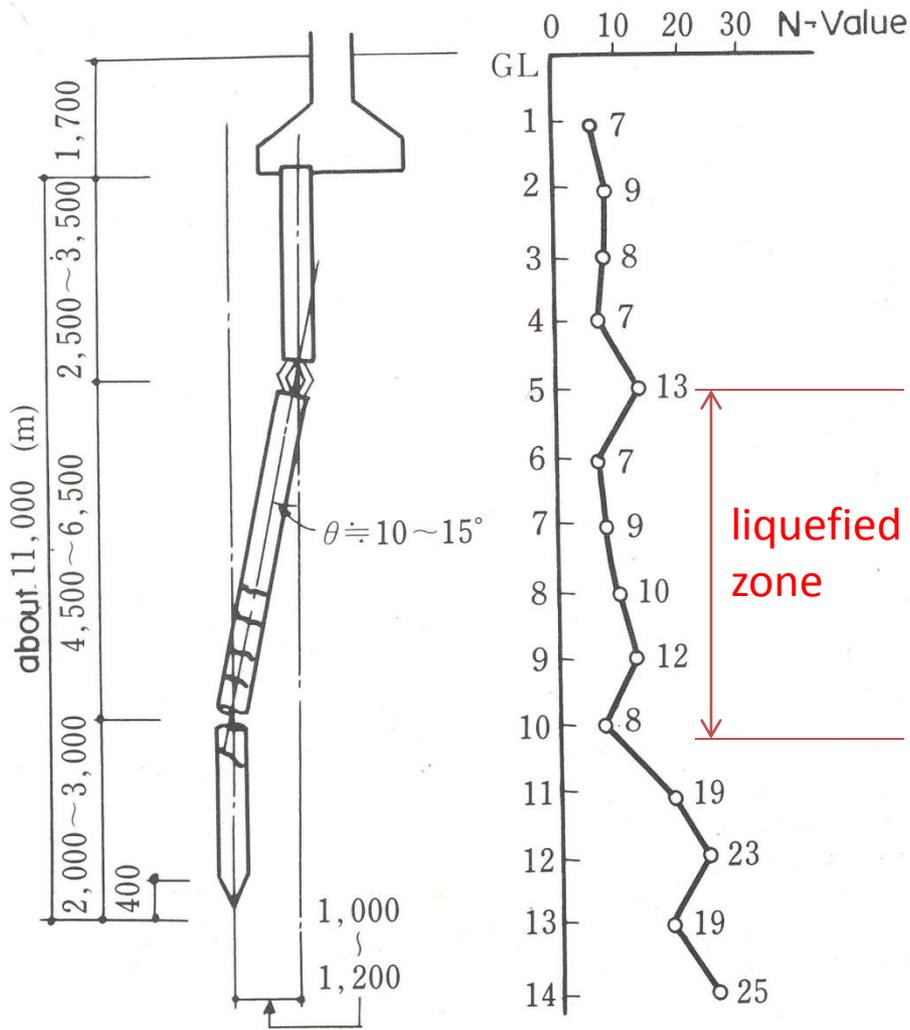
Post earthquake pile  
configuration and  
standard penetration  
resistance beneath N  
Building
