# Earthquake Damage to Building Foundations

T. Leslie Youd

Short course on Evaluation of Liquefaction  
Hazard for Engineering Practice

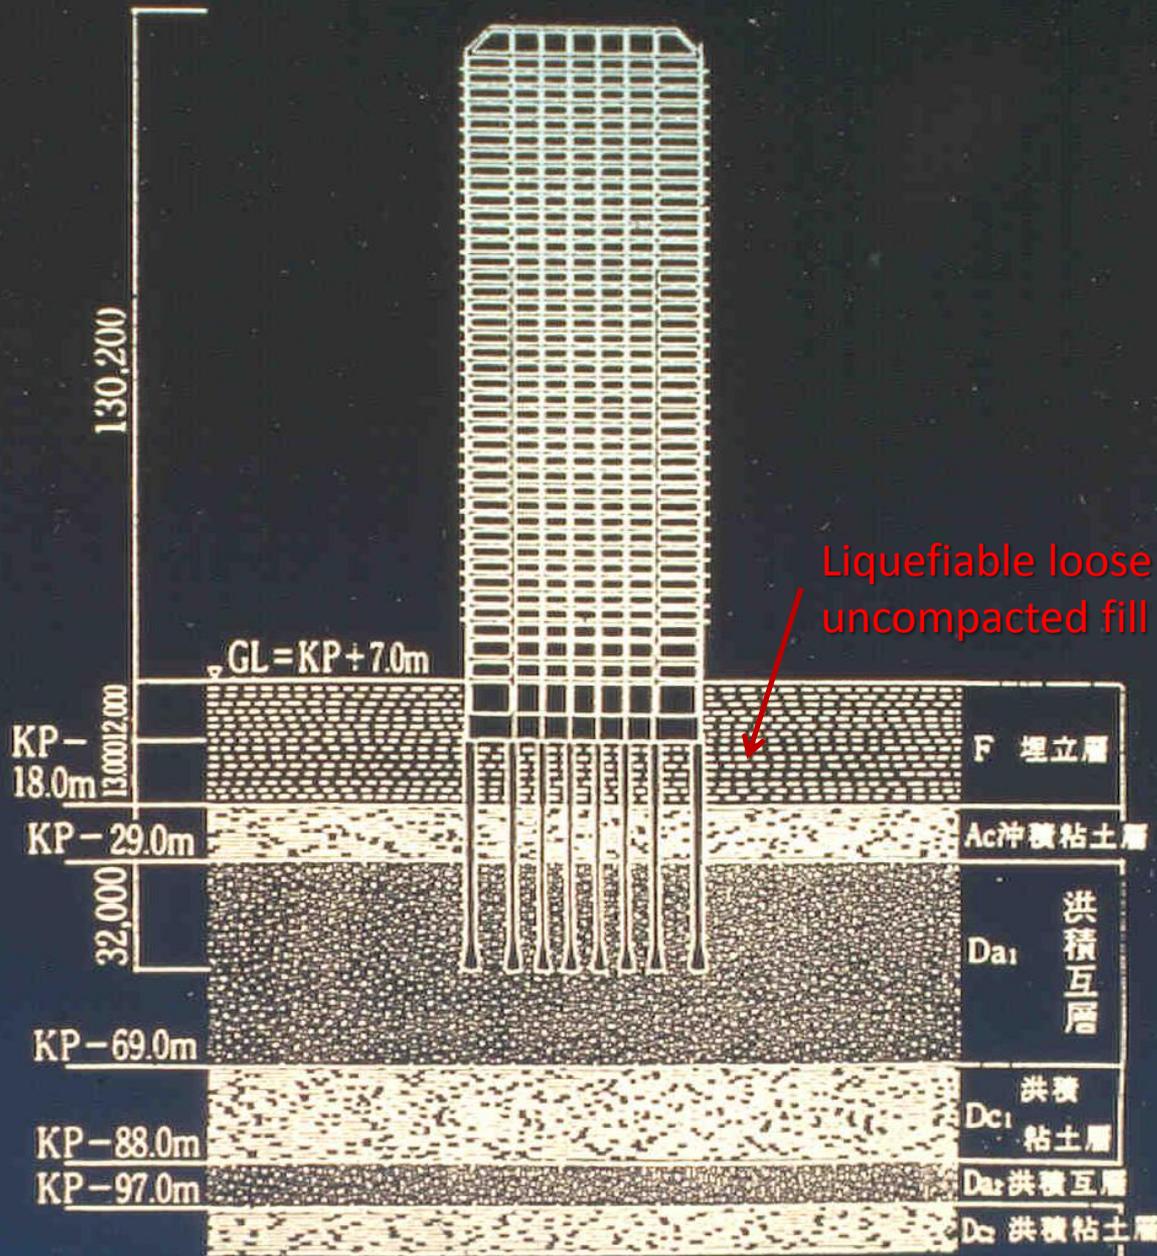
Cross section showing pile configuration for a building on Rokko Island, Kobe, Japan. Area was shaken by 1995 Kobe, Japan Earthquake.

Liquefaction and ground settlement (average 0.75 m) occurred without significant structural damage to buildings on pile foundations.

Piles have proven effective structural mitigation measure against liquefaction at sites with tolerable lateral ground displacement.

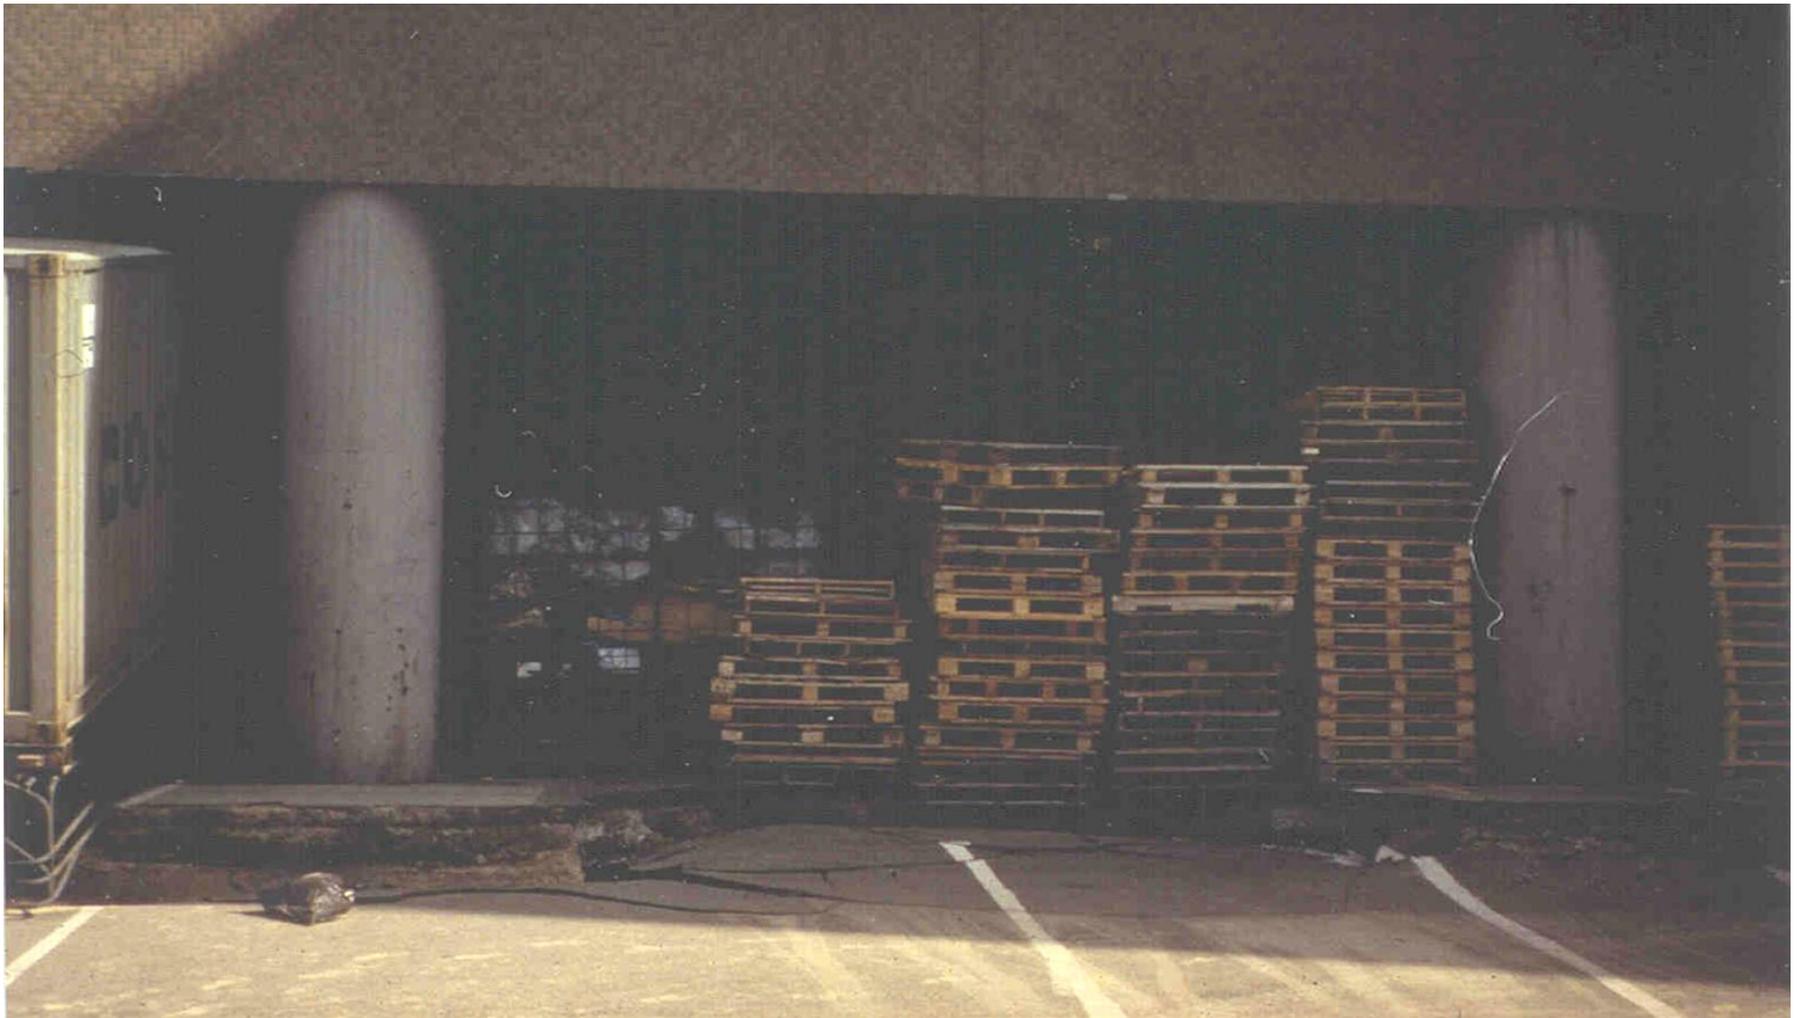
0.5 m of differential settlement between building, founded on piles, and ground caused no significant structural damage; Port Island, Kobe, Japan (Les Youd photo)

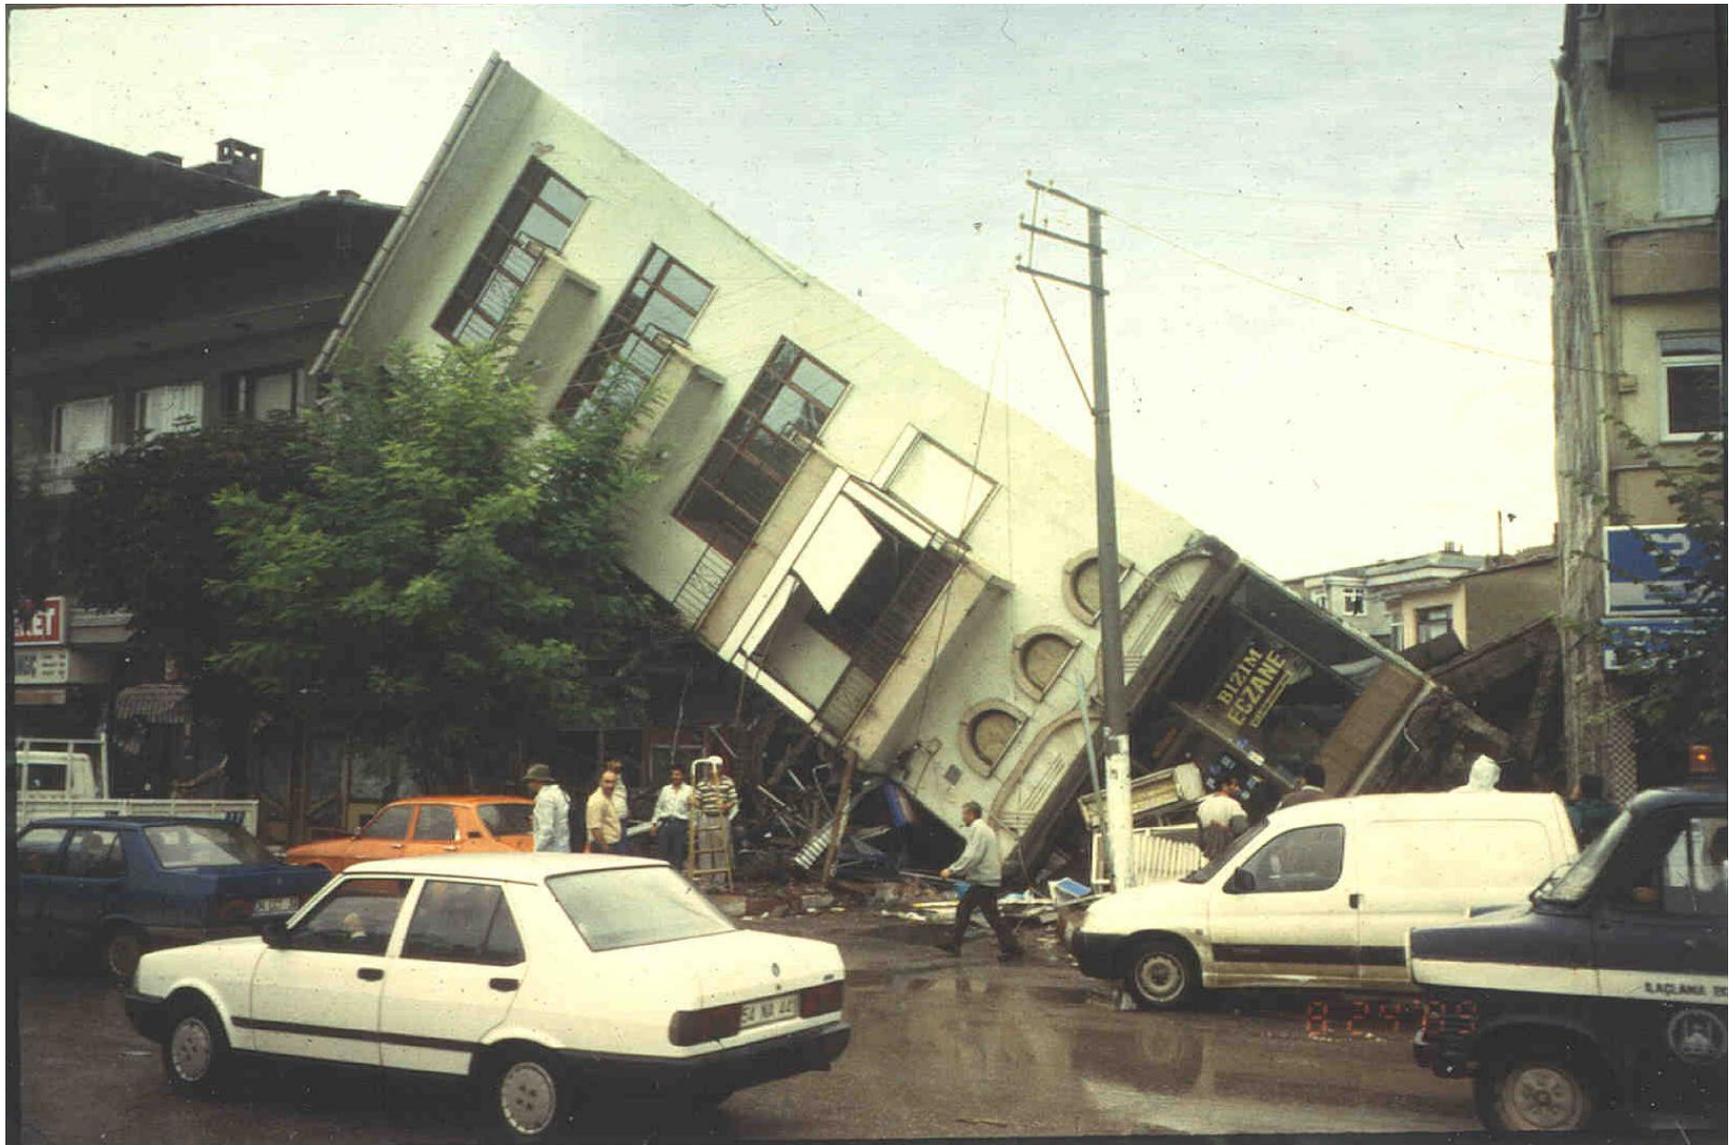
Tipped building in Adapazari, Turkey caused by liquefaction-induced loss of bearing strength during 1999 Koaceli, Turkey earthquake (Les Youd photo)

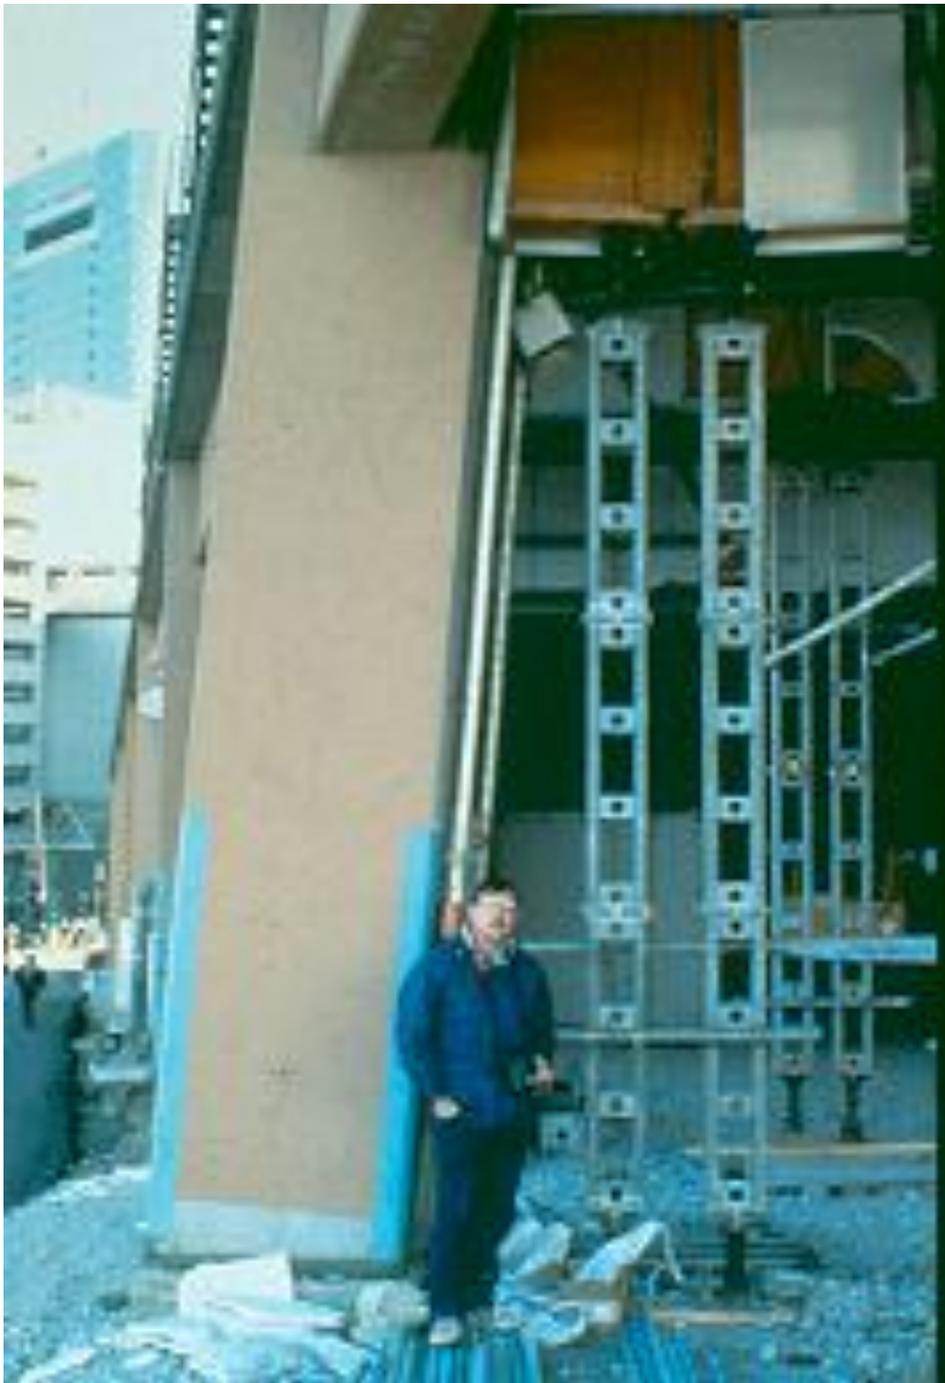
Tall building supported on piles pulled apart at foundation level by lateral spread toward nearby island edge; building located on, Rokko Island, Kobe, Japan and was damaged during 1995 Kobe earthquake (Les Harder photo)

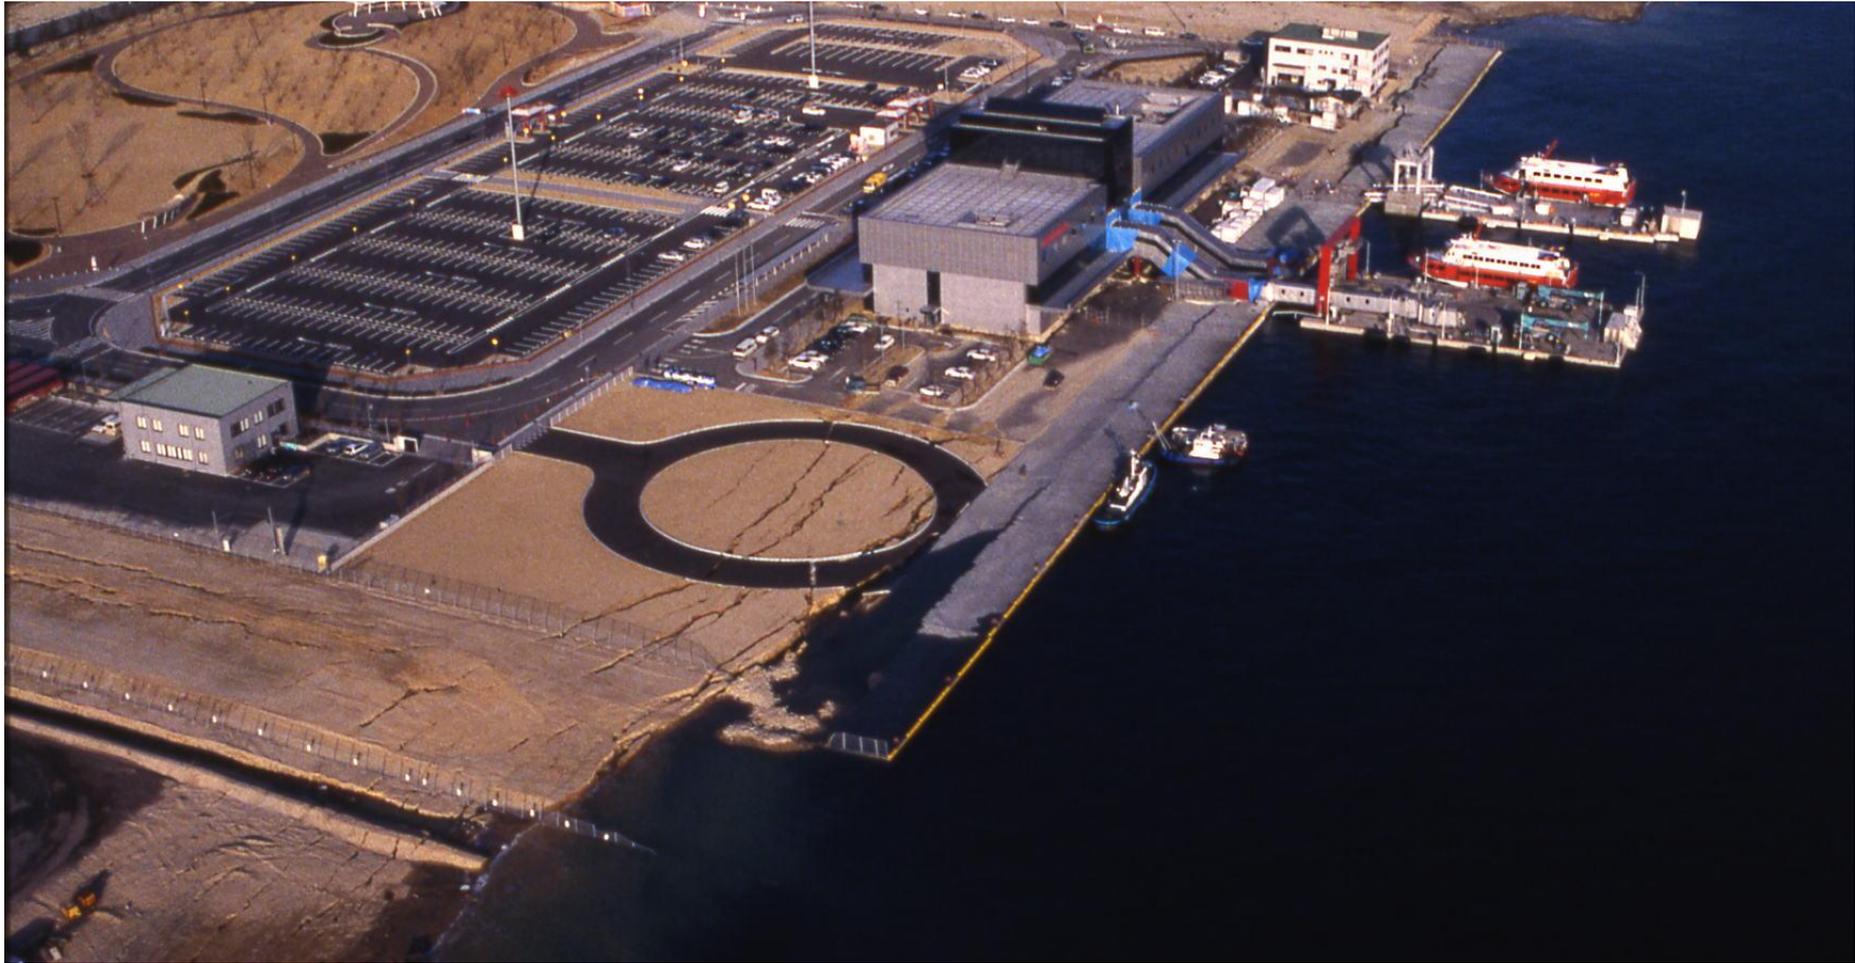
Ferry Building on Port Island undamaged by lateral spread (note fissures in graded area) and ground settlement during 1995 Kobe, Japan earthquake; building is founded on reinforced concrete mat supported on reinforced concrete shafts (Les Youd photo)

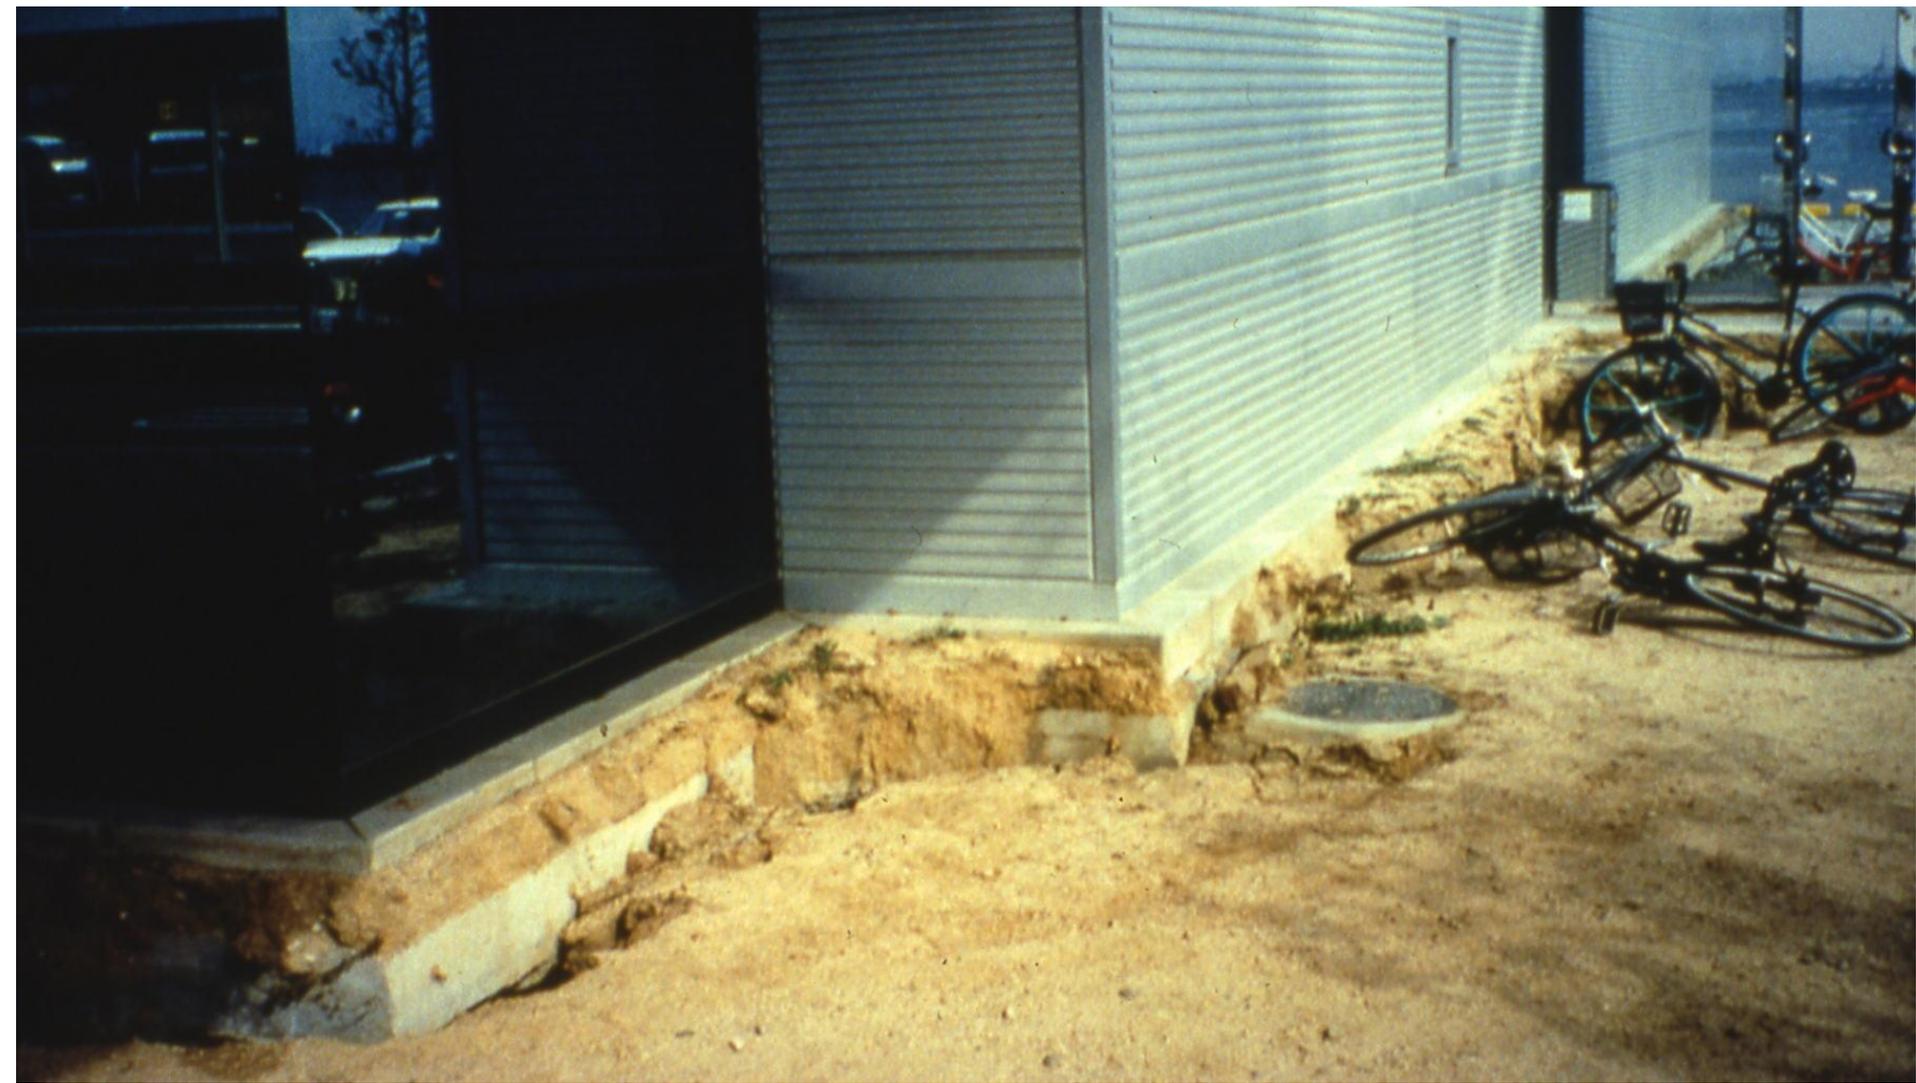
Ground settled approximately 0.5 m around Ferry Building  
(Les Youd photo)

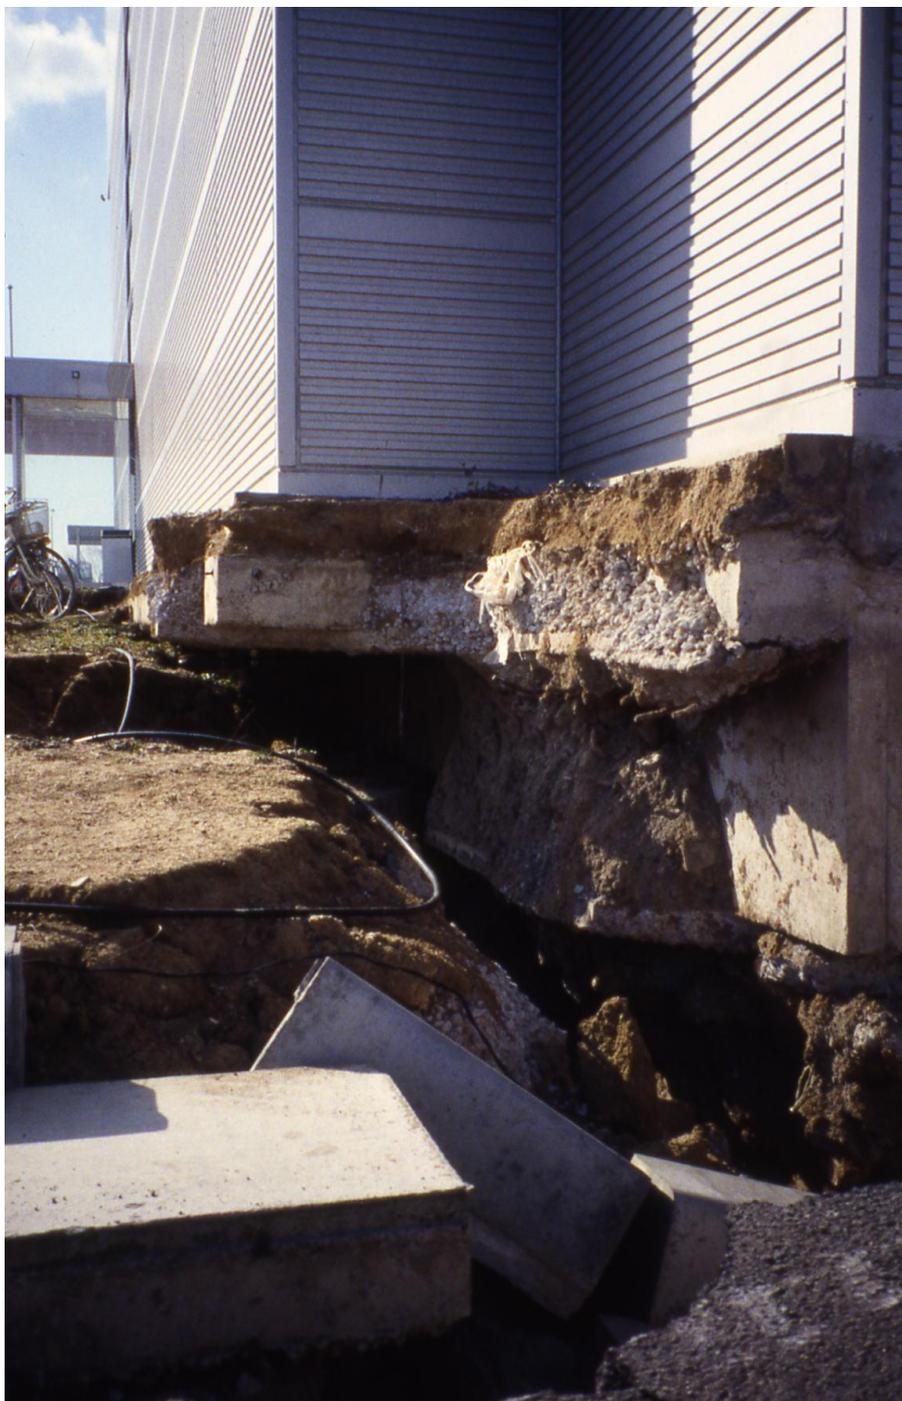
Waterfront side of Ferry Building showing pavement that settled and pulled away from building due to liquefaction and lateral spread, exposing foundation elements  
(Les Youd photo)

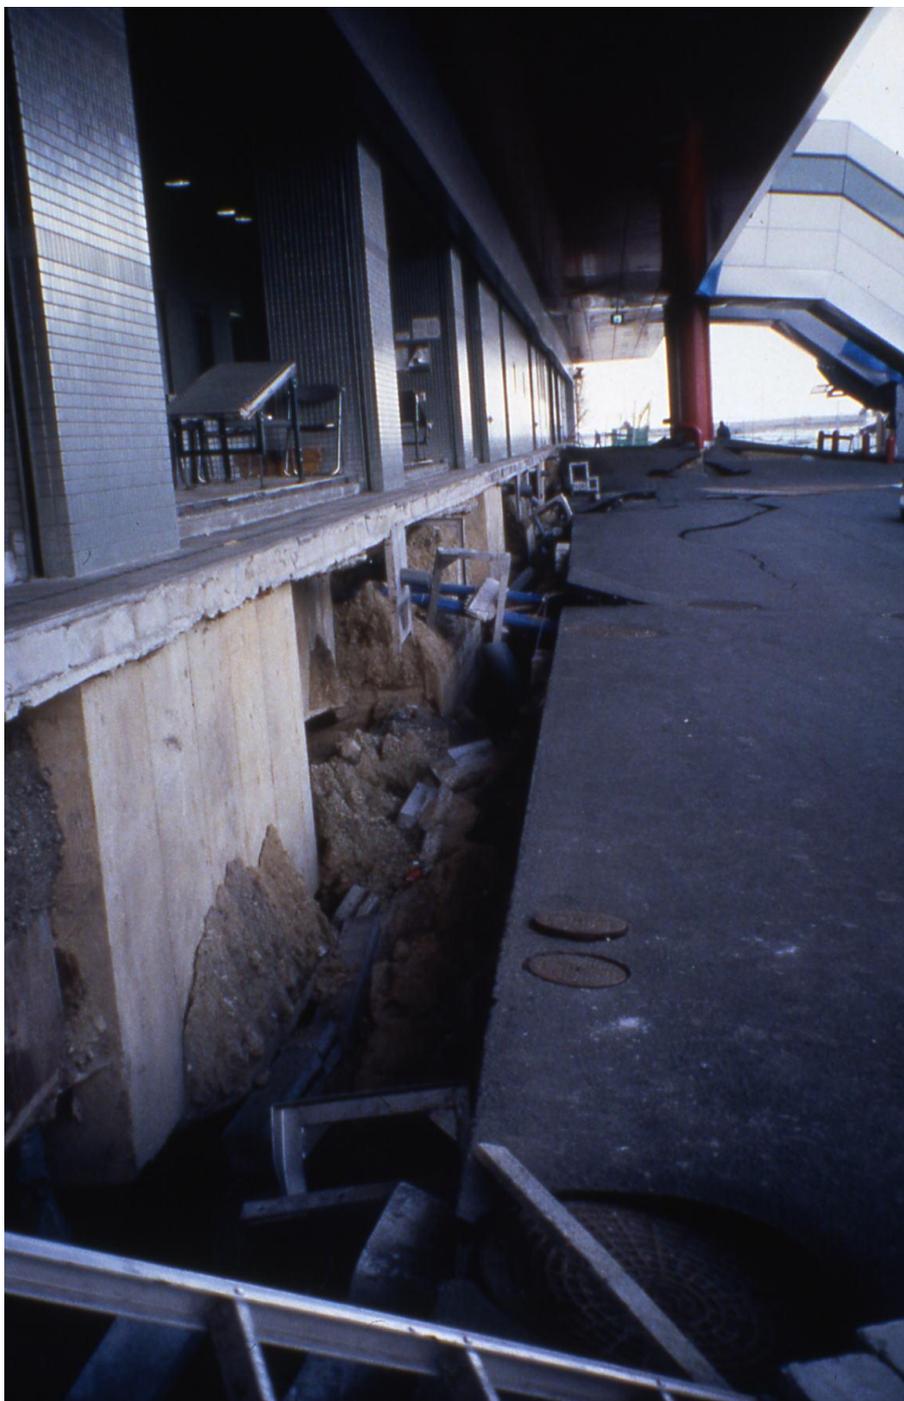
Waterfront side of Ferry Building showing pavement that settled and pulled away due to liquefaction, ground settlement and lateral spread; Jetways were pulled away from building and utilities broken but building was undamaged  
(Les Youd photo)

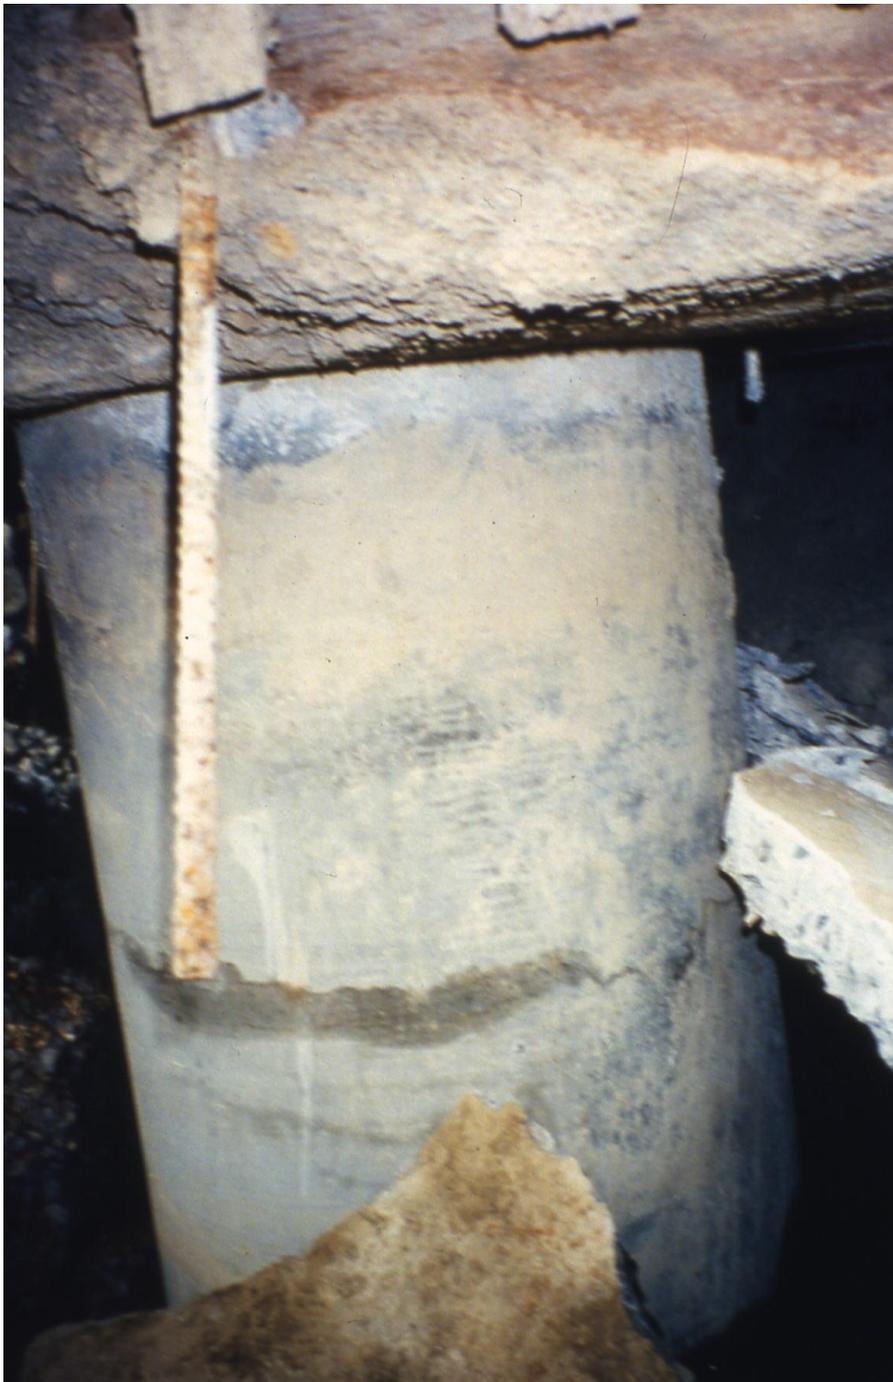
Shaft exposed by pull away of soil on waterfront side of Ferry Building; shaft is strongly tied into the concrete mat, pinning the shaft at the top while the bottom is pinned in alluvial gravels beneath the liquefied zone

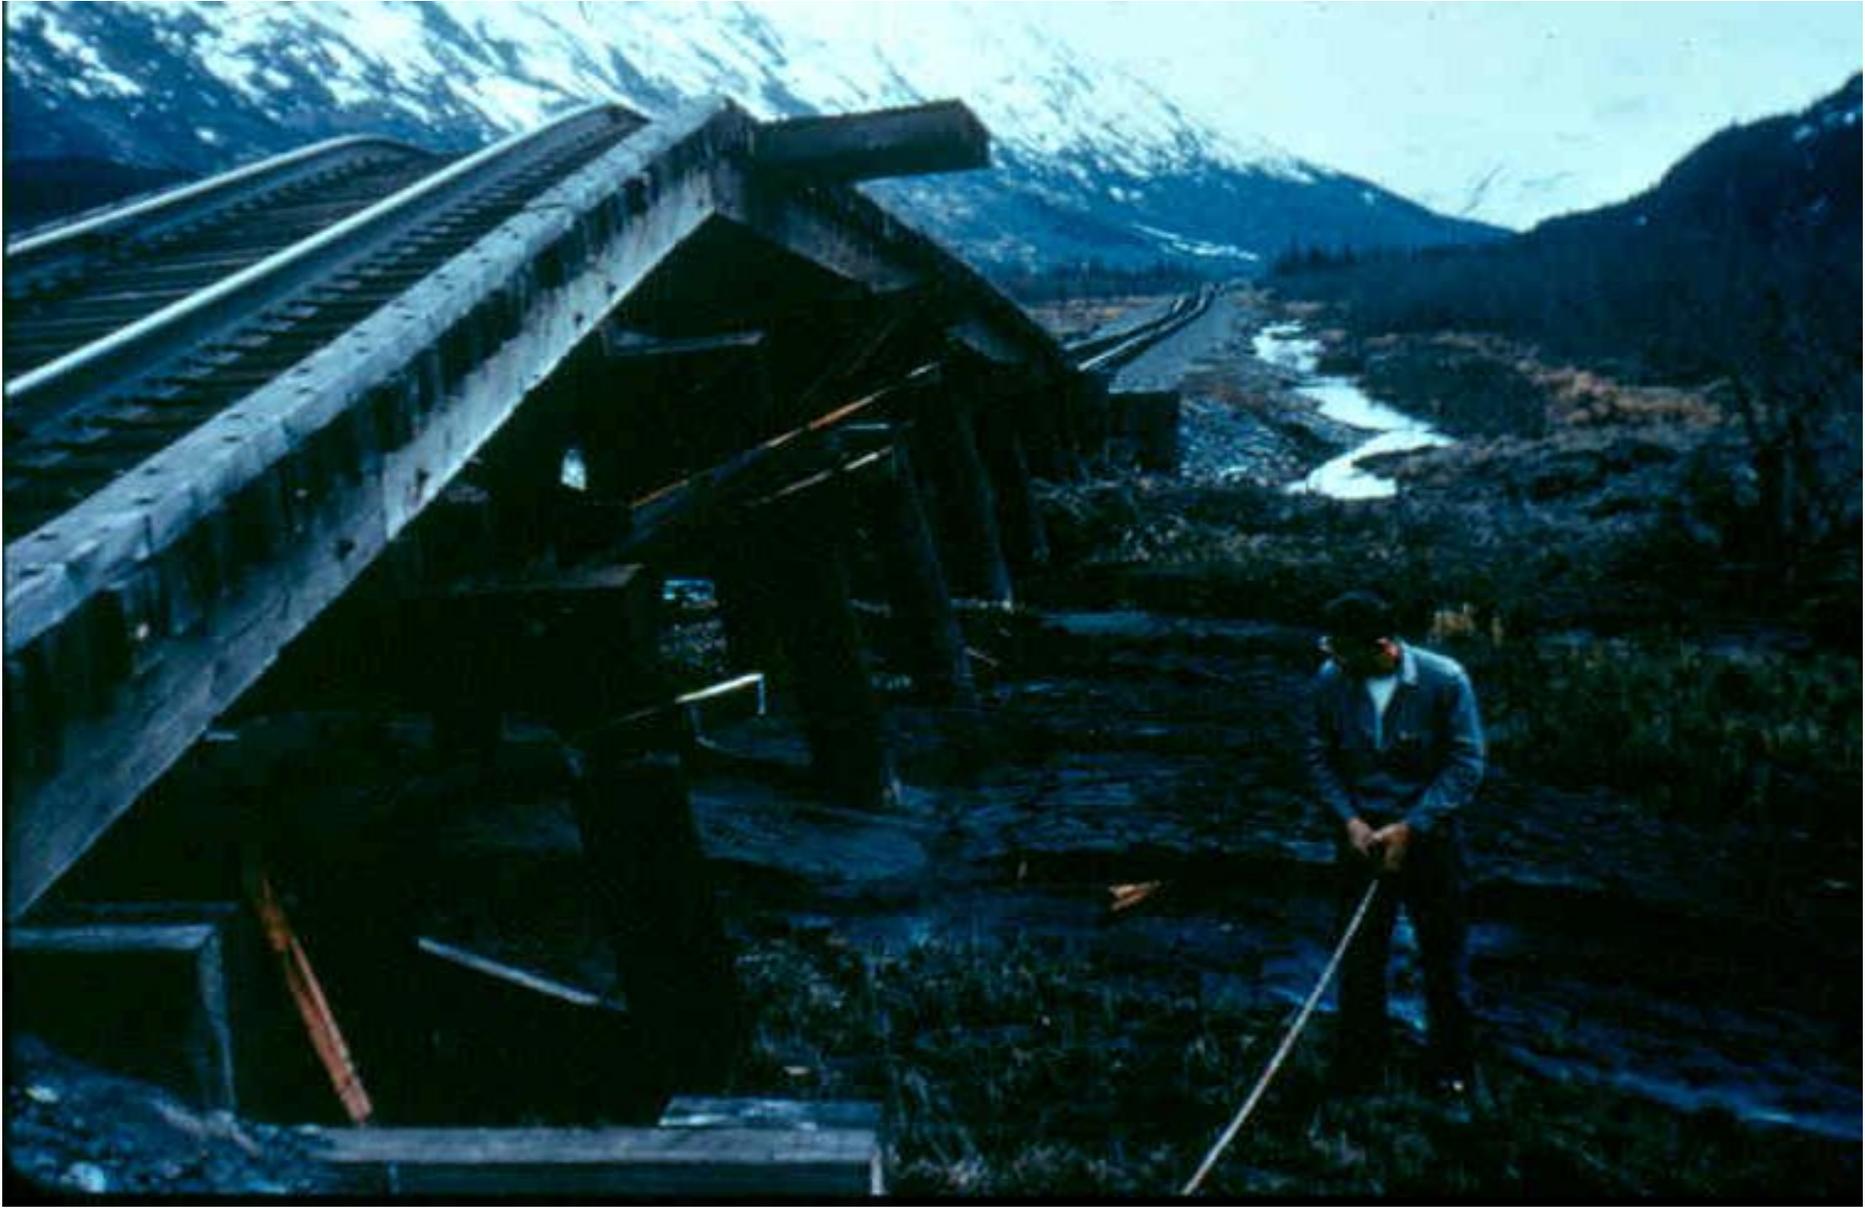
1964 Alaska earthquake: lateral spread floodplain deposits displaced abutments 1 m toward channel buckling deck upward (USGS photo)

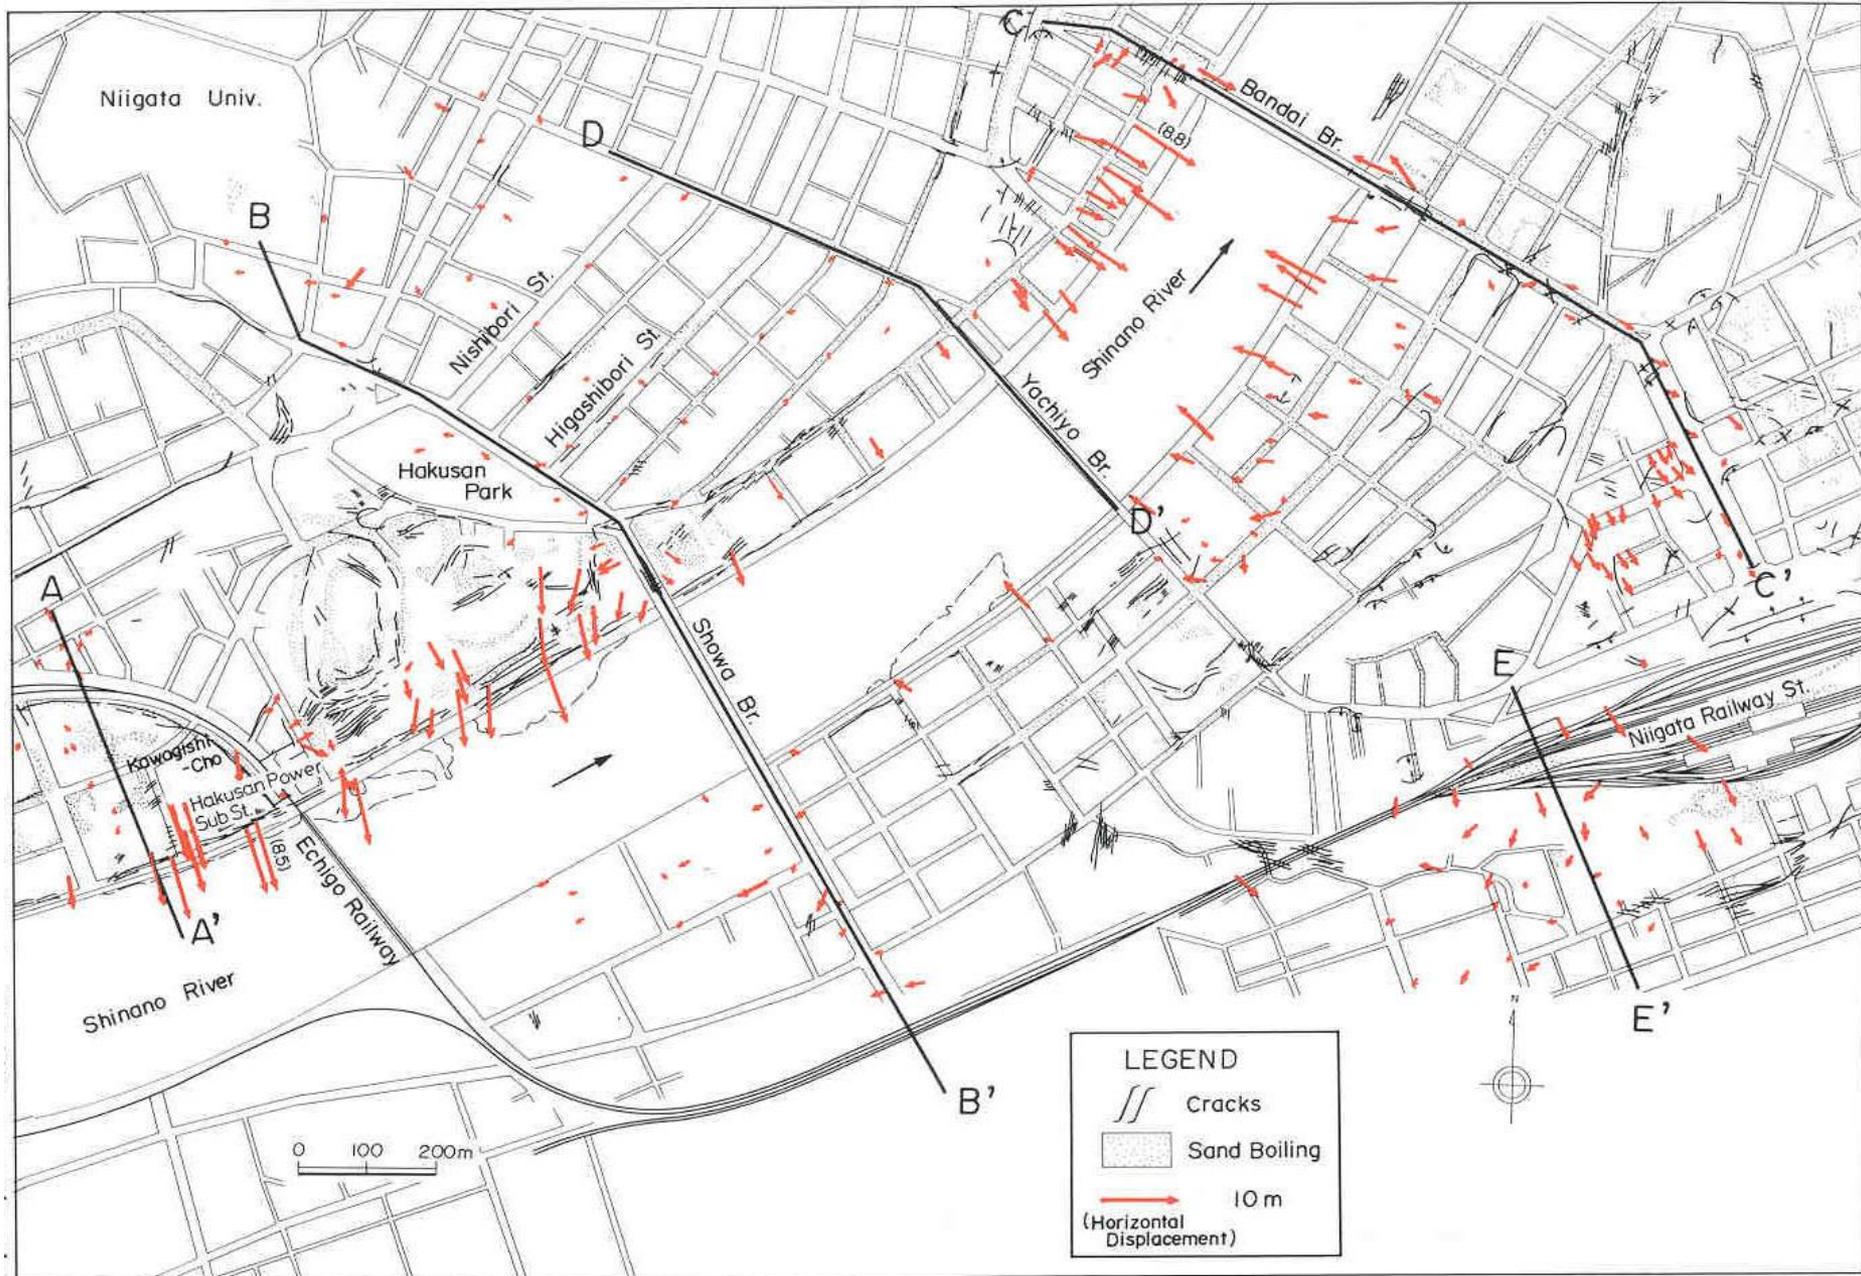
Lateral spread vectors, 1964 Niigata, Japan Earthquake (Hamada et al, 1986)

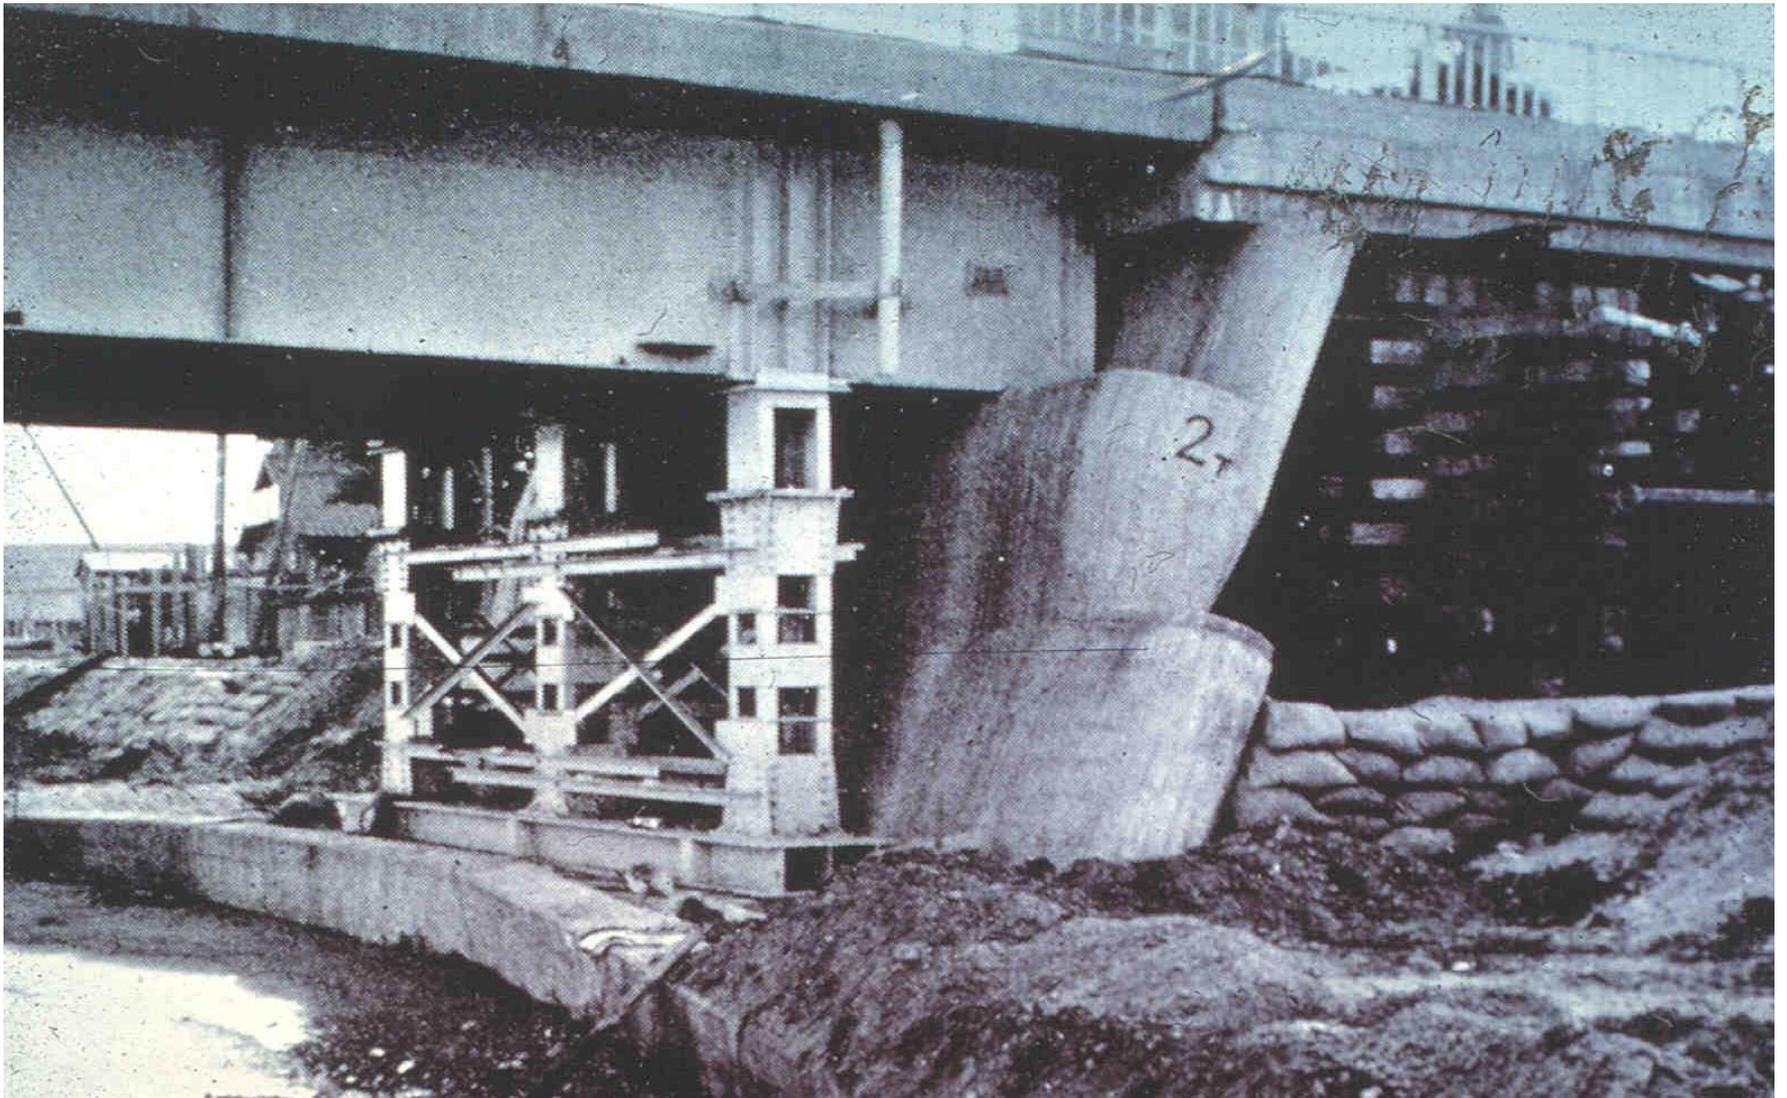
Bridge pier displaced toward Shinano River during 1964 Niigata, Japan earthquake (1964 Niigata, Japan Earthquake Report)
