# Earthquake Damage to Building Foundations

T. Leslie Youd

Short course on Evaluation of Liquefaction  
Hazard for Engineering Practice

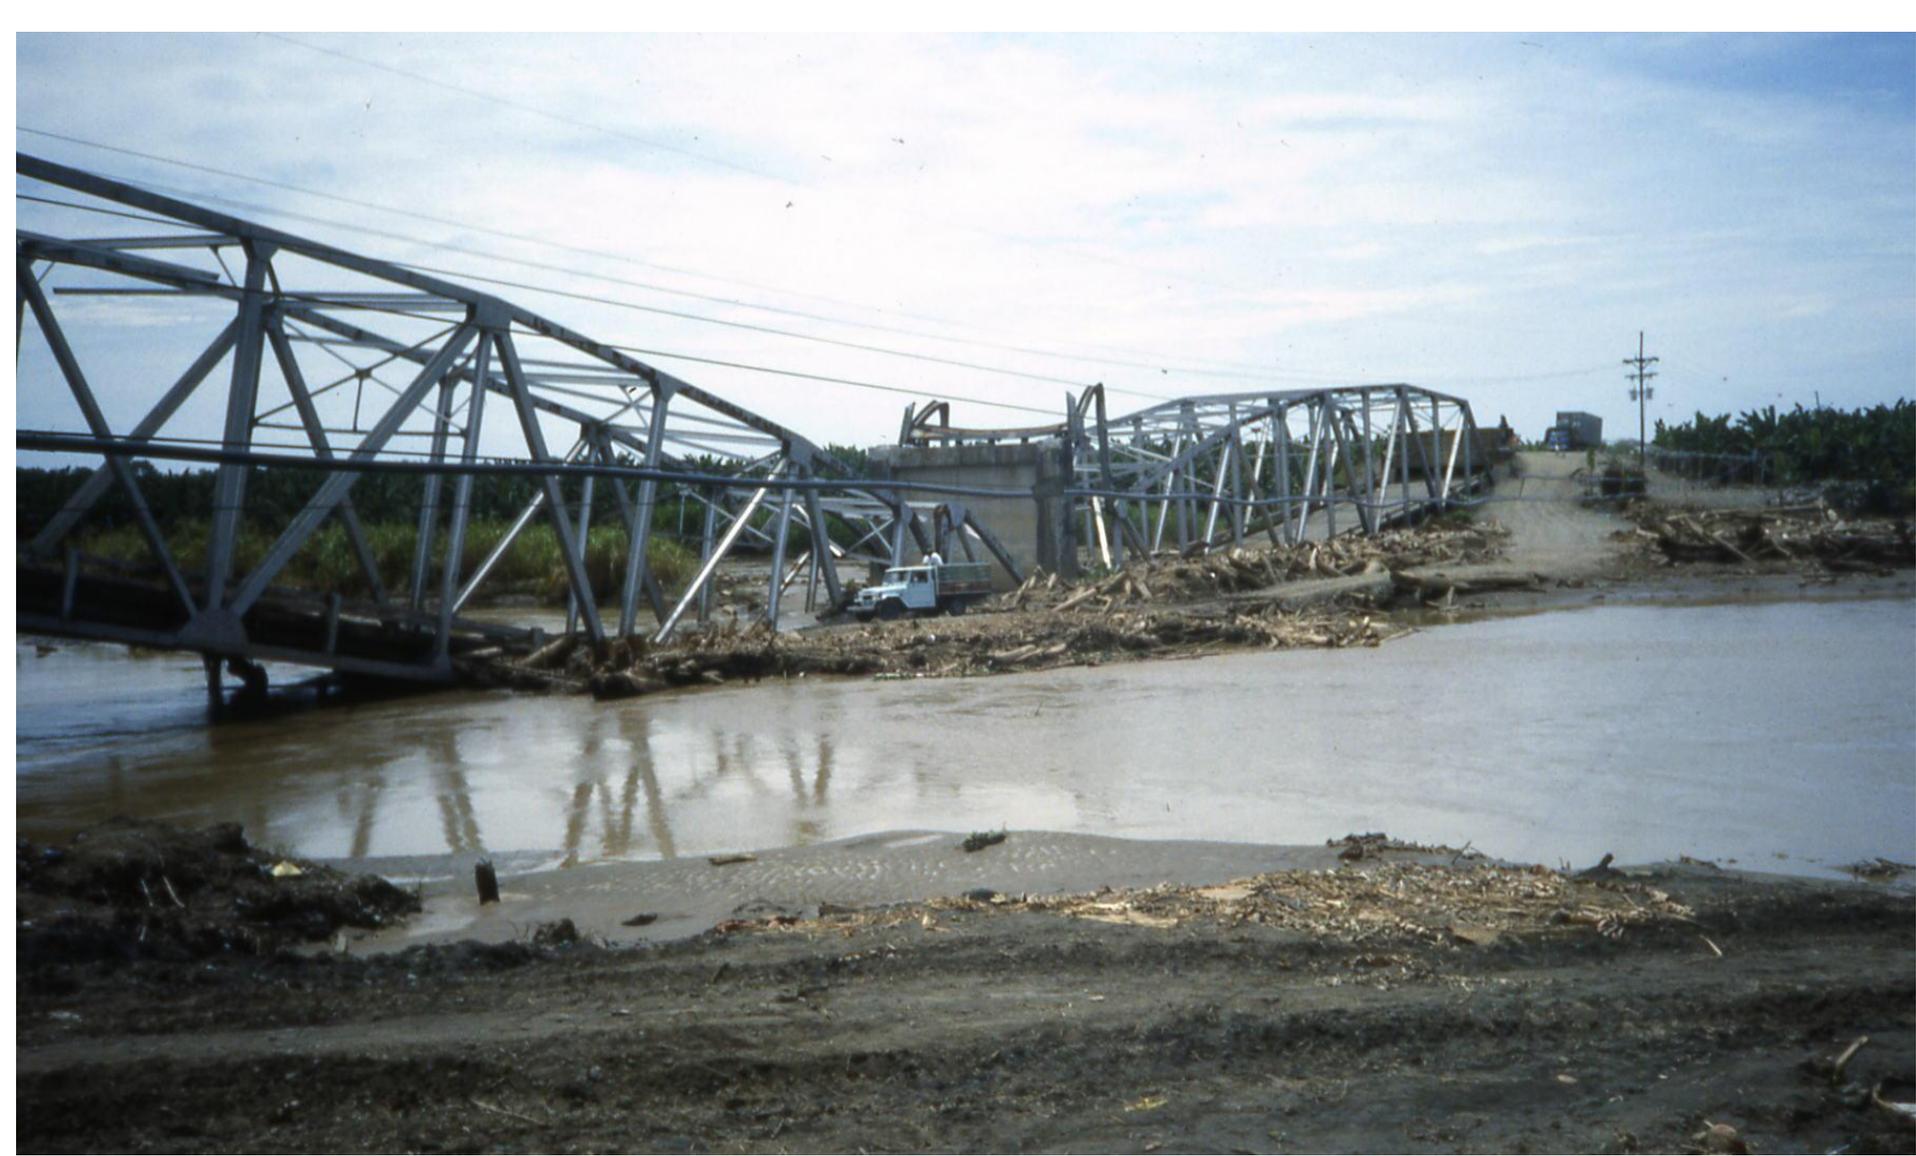
Collapsed highway bridge over Rio Estrella, 1991 Limon Costa Rica earthquake (Les Youd photo)

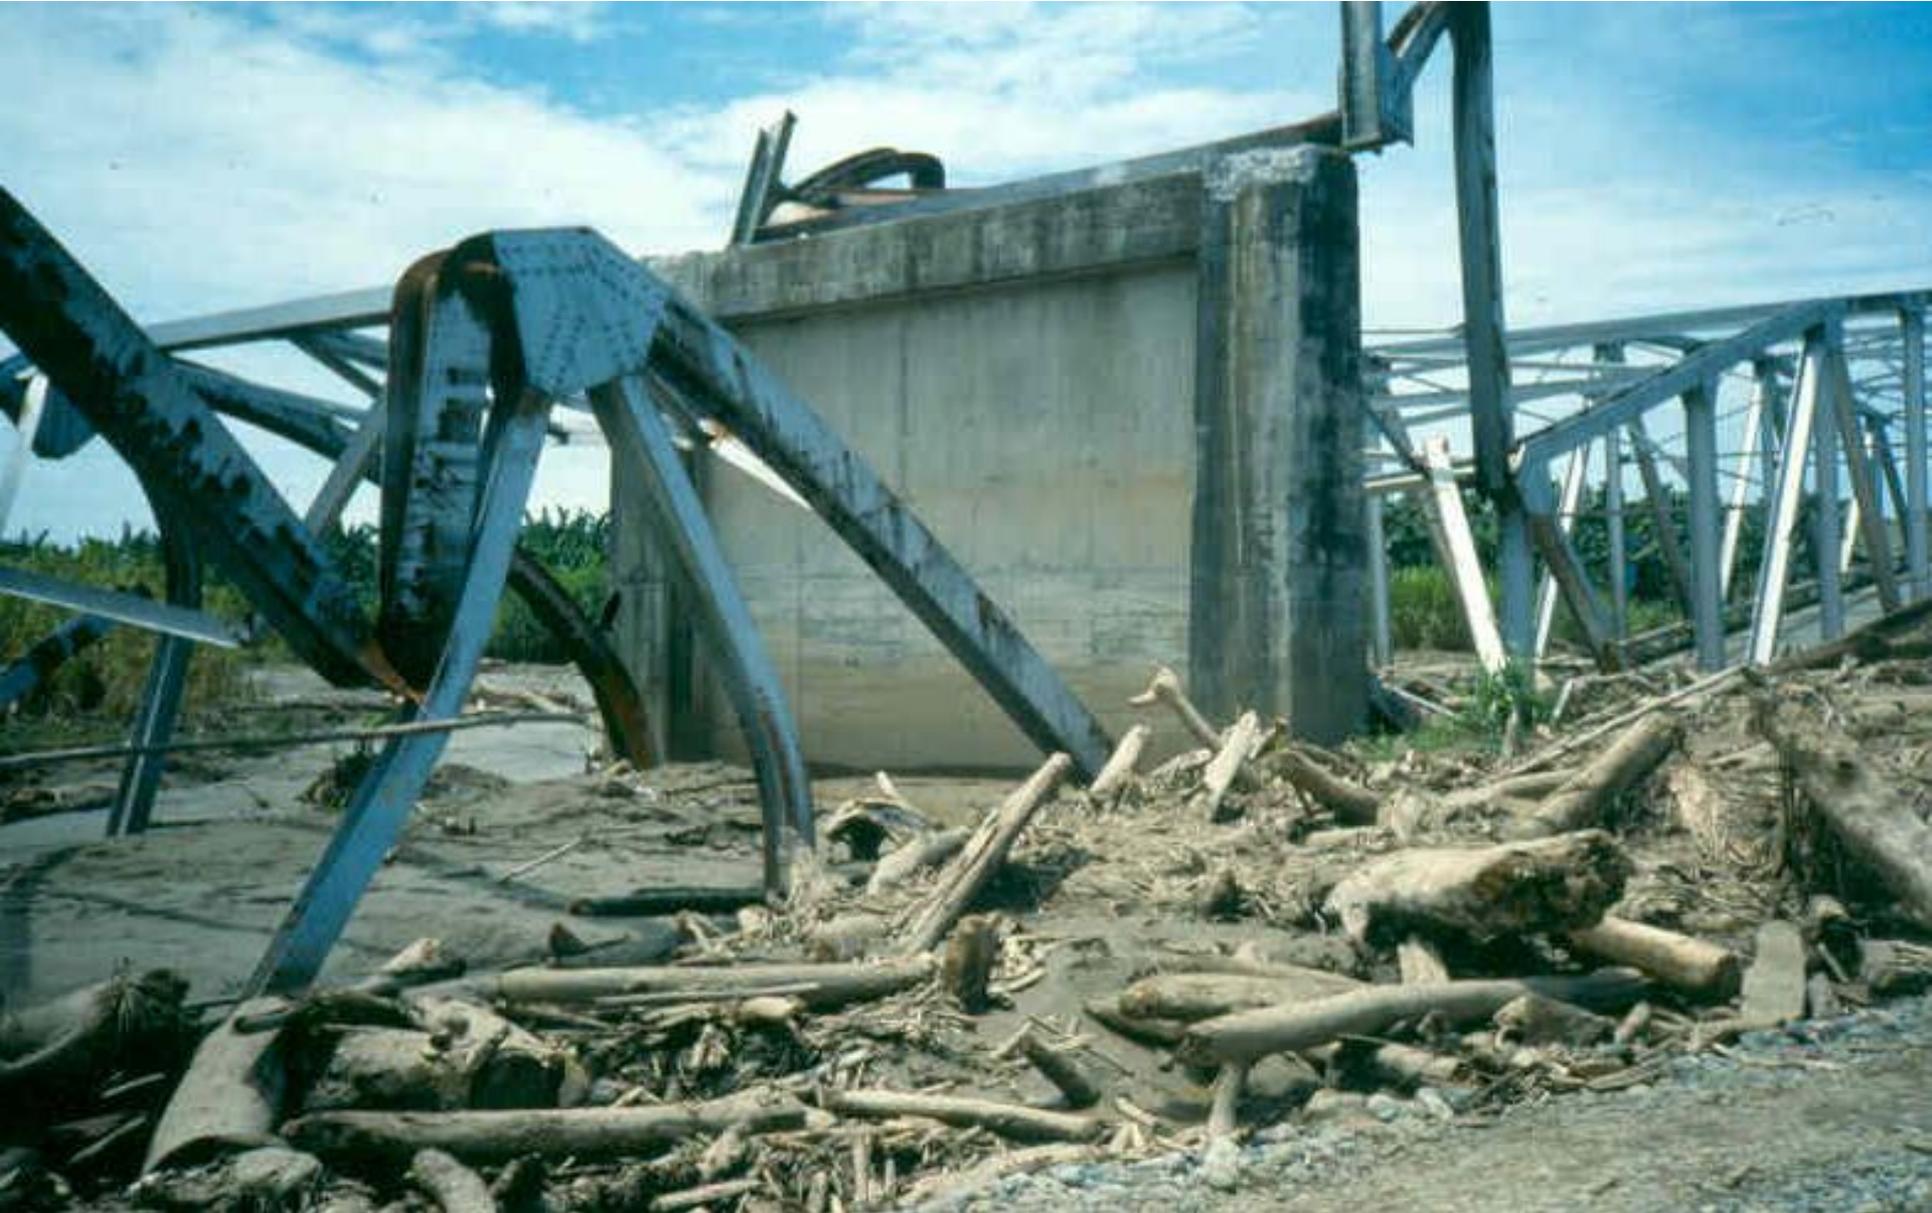
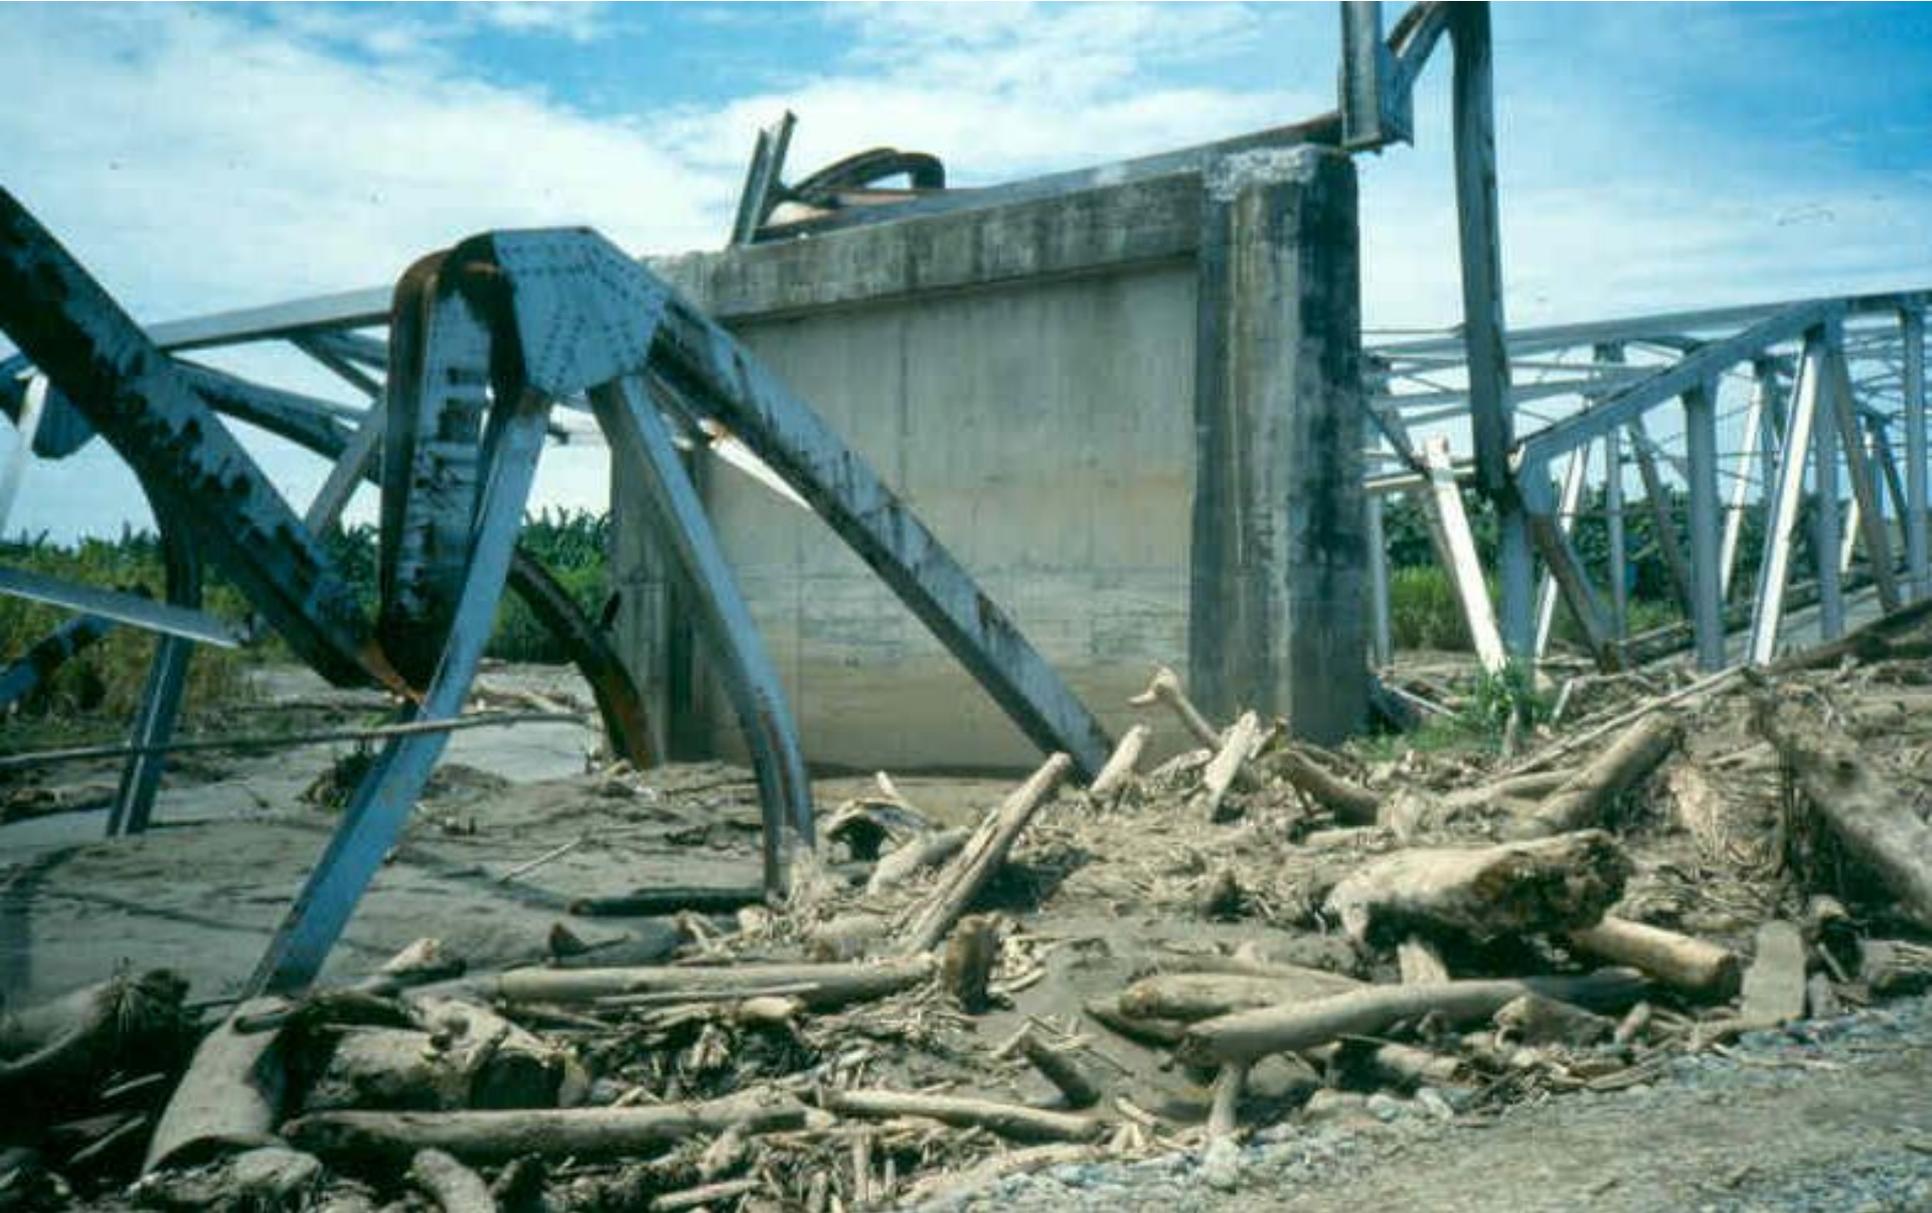
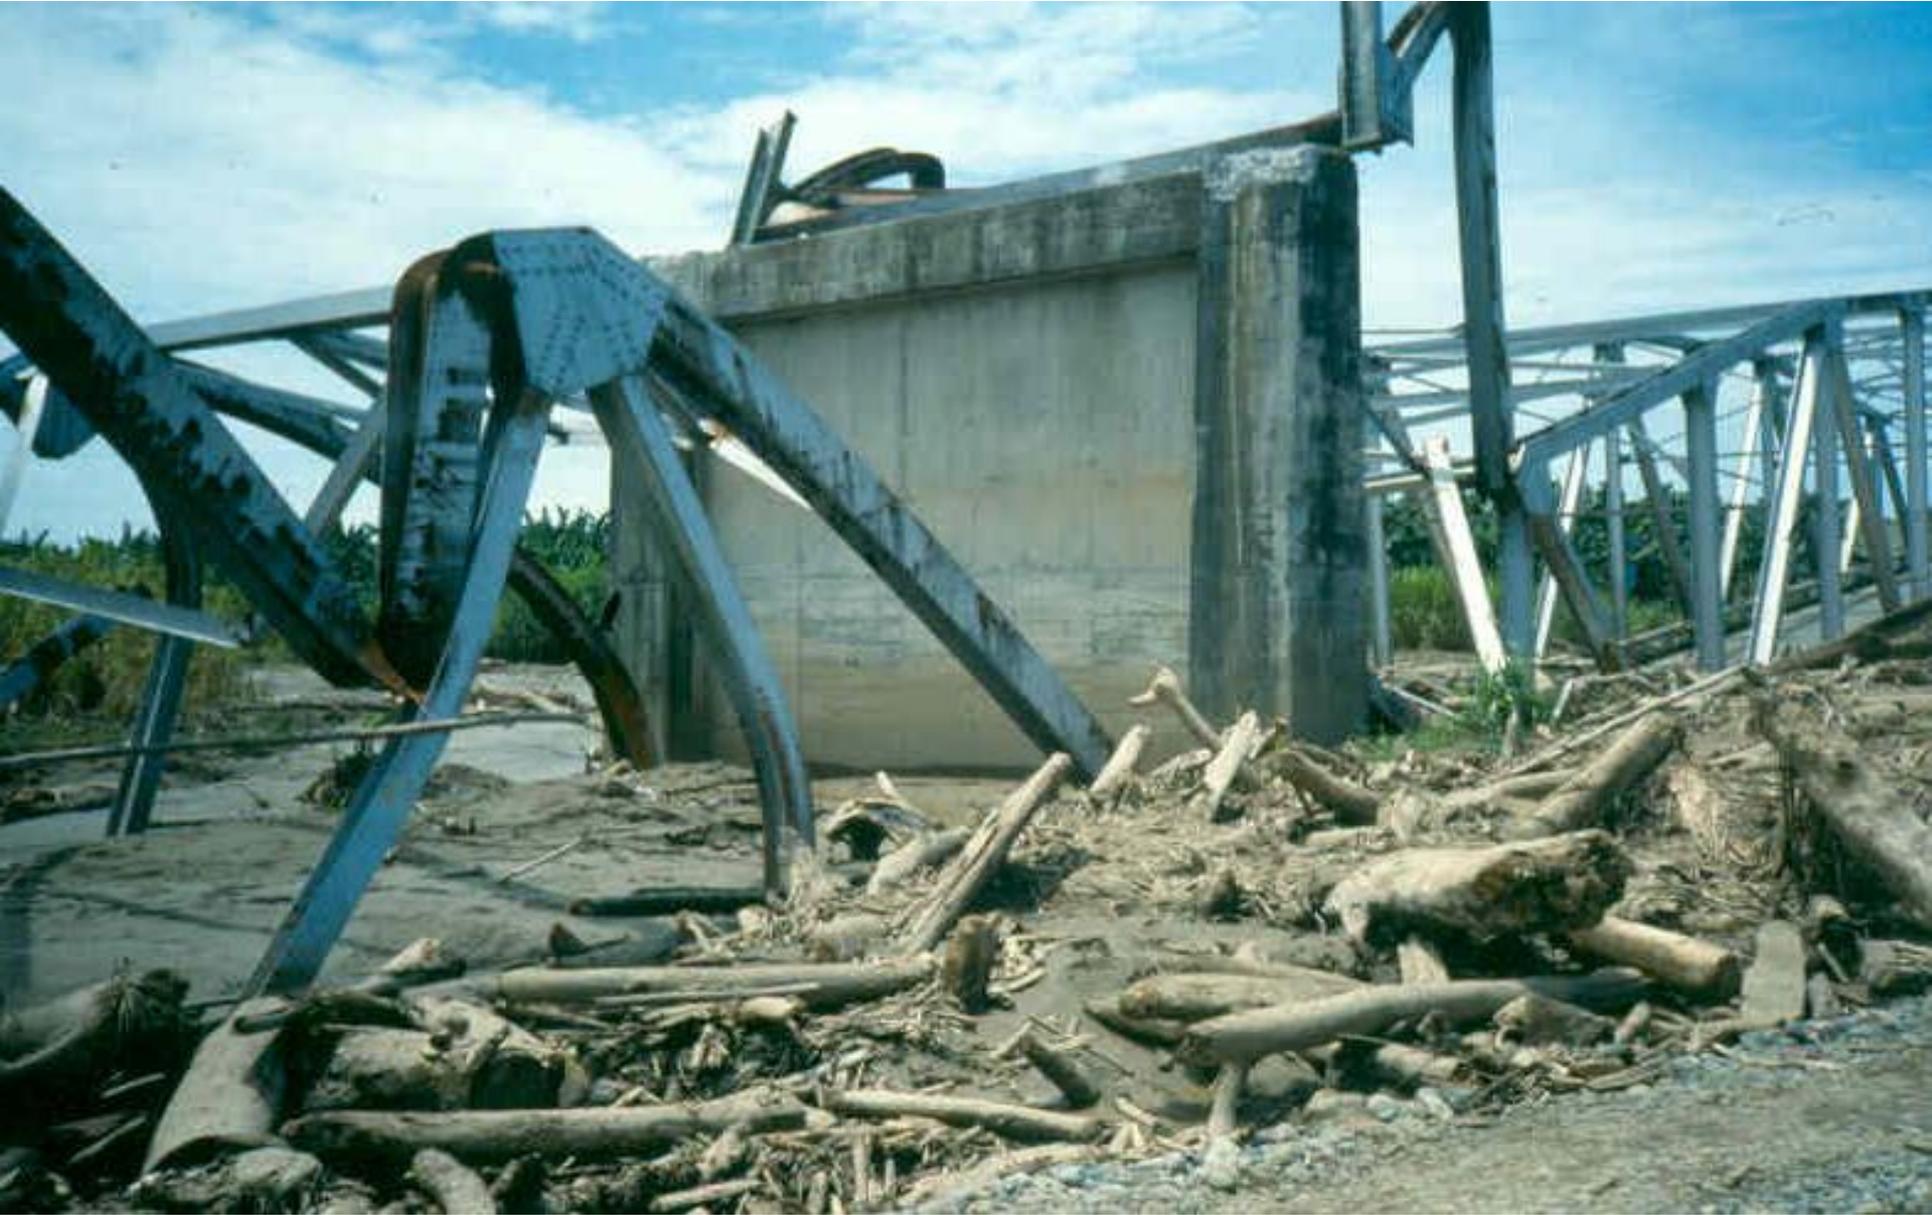
Central pier of Rio Estrella highway bridge

1991 Limon Costa Rica: Central pier of Rio Estrella highway bridge

Central pier of Rio Estrella, Costa Rica highway bridge (Les Youd photo)

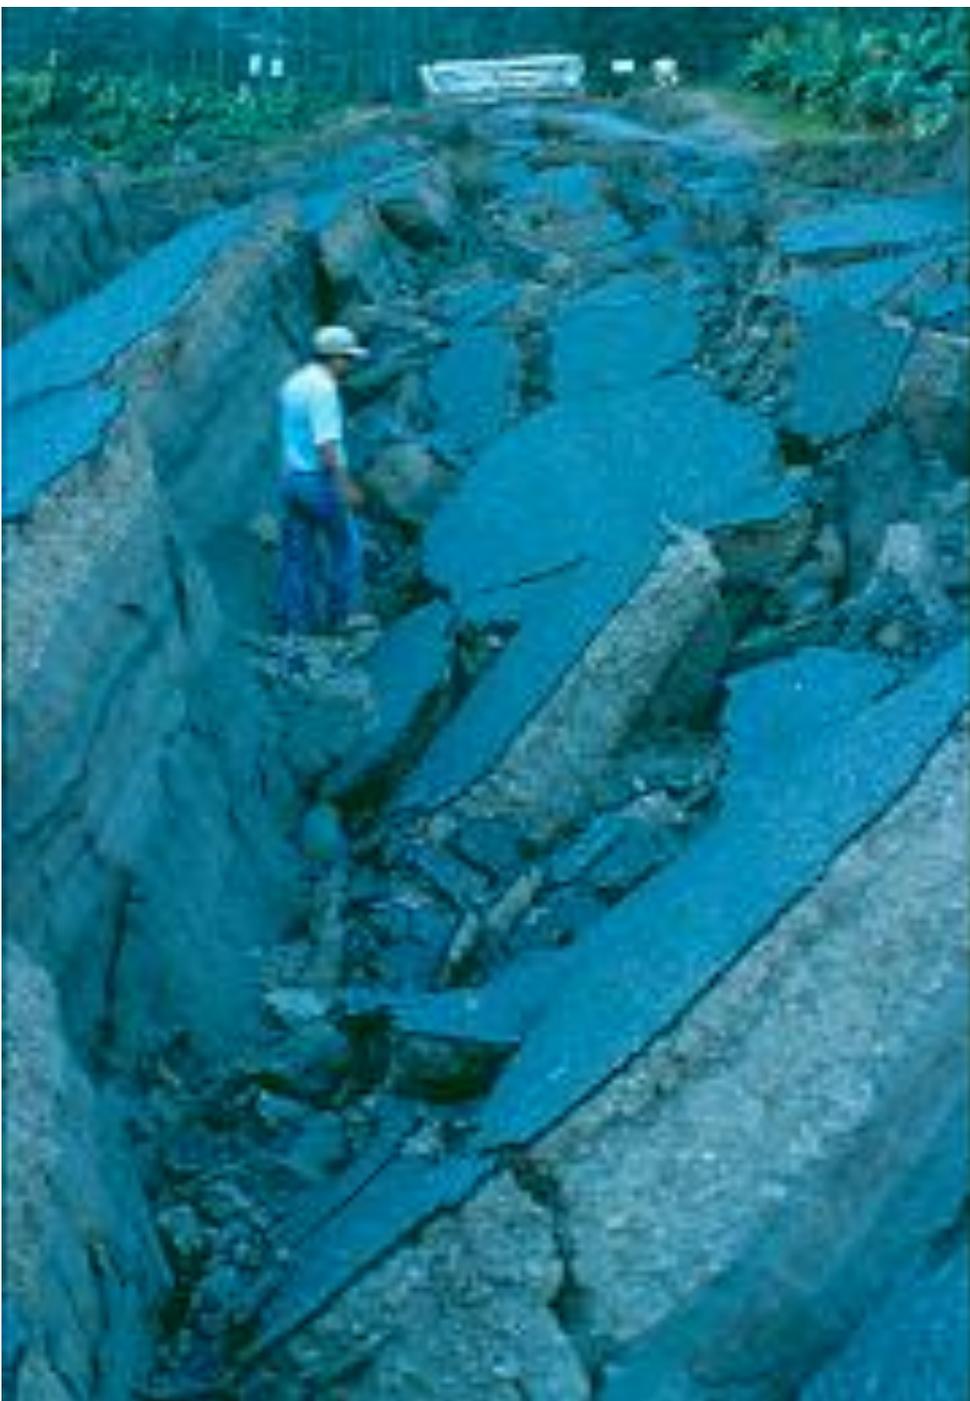
Shattered and spread embankment approach to collapsed Rio Estrella highway bridge (Univ. of Costa Rica photo)

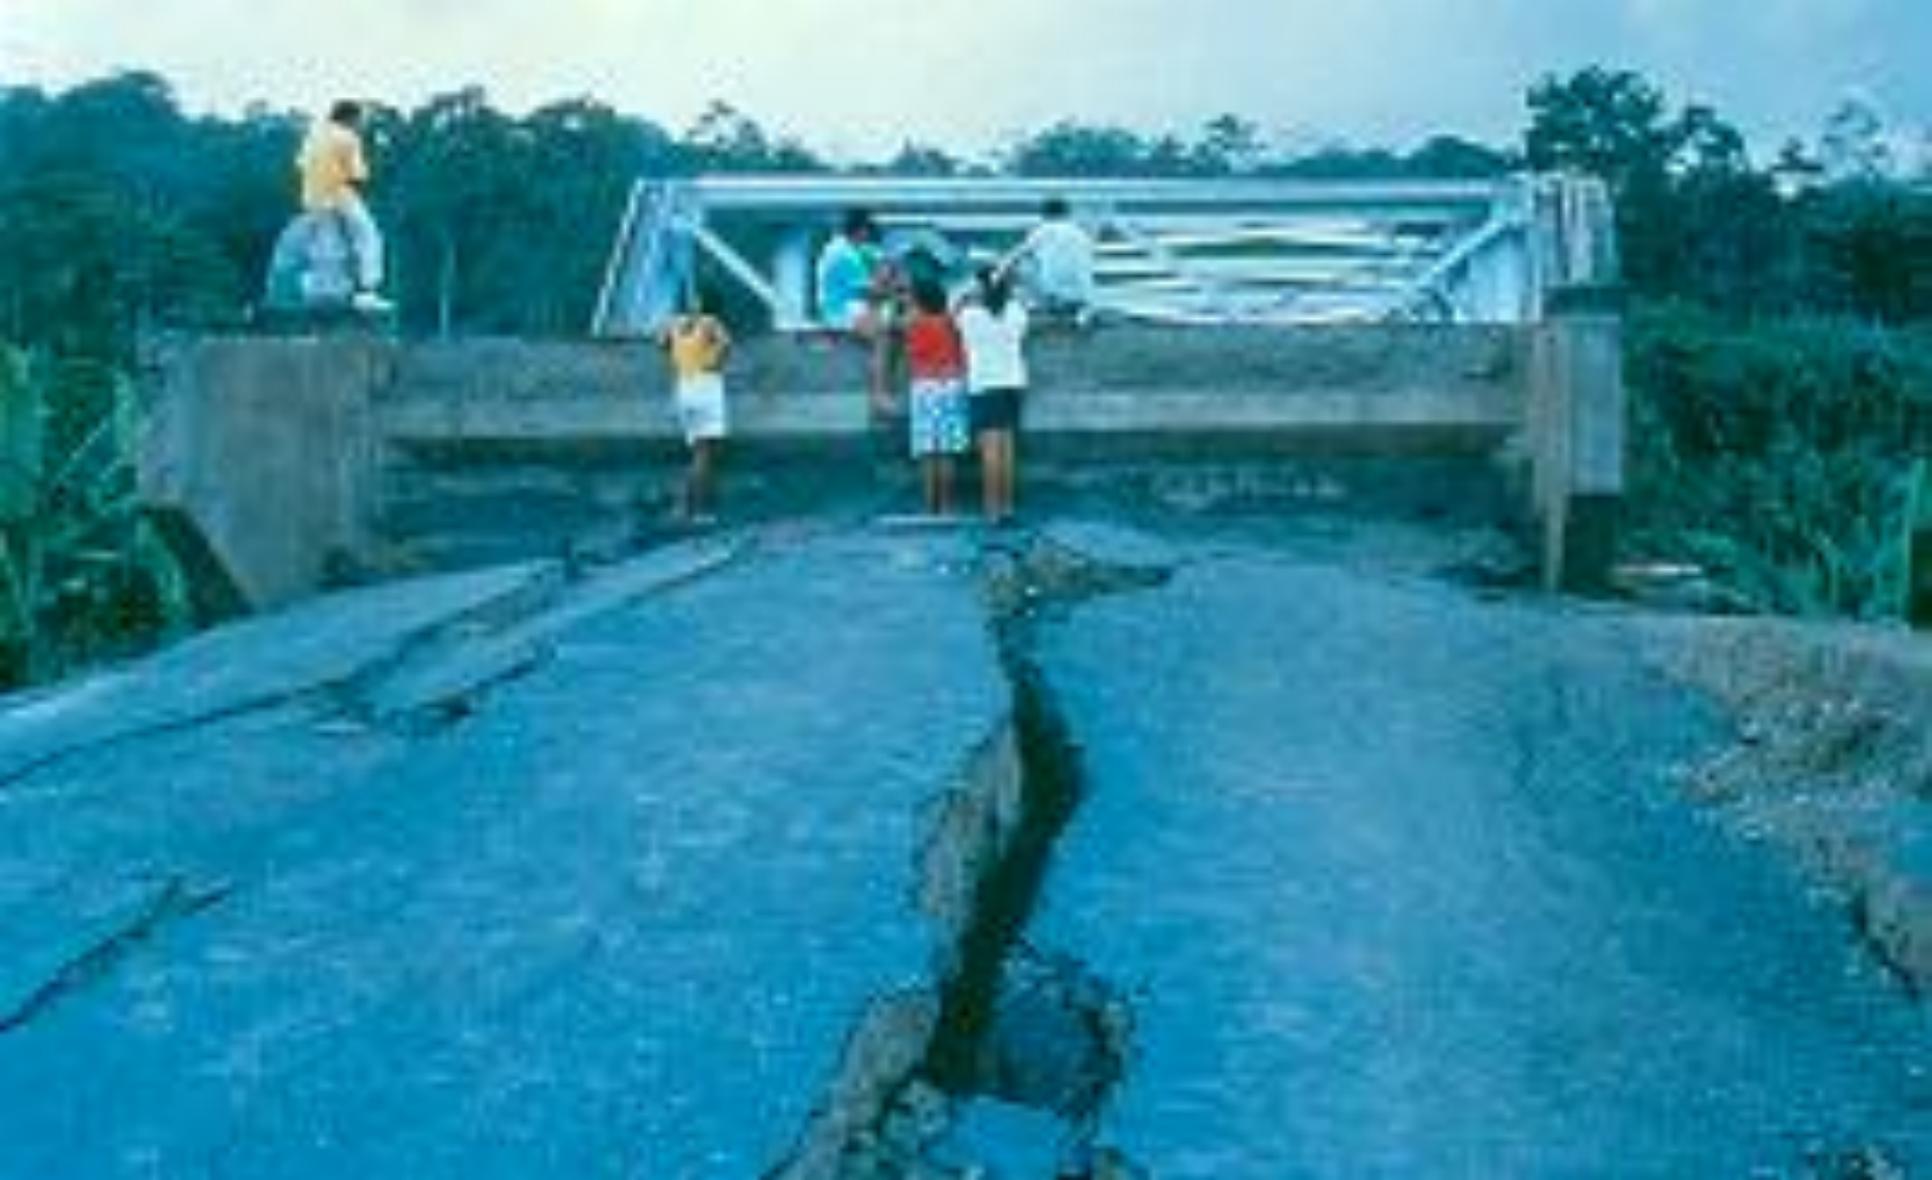
Cracked and settled highway embankment at abutment of collapsed Rio Estrella highway bridge (University of Costa Rica photo)

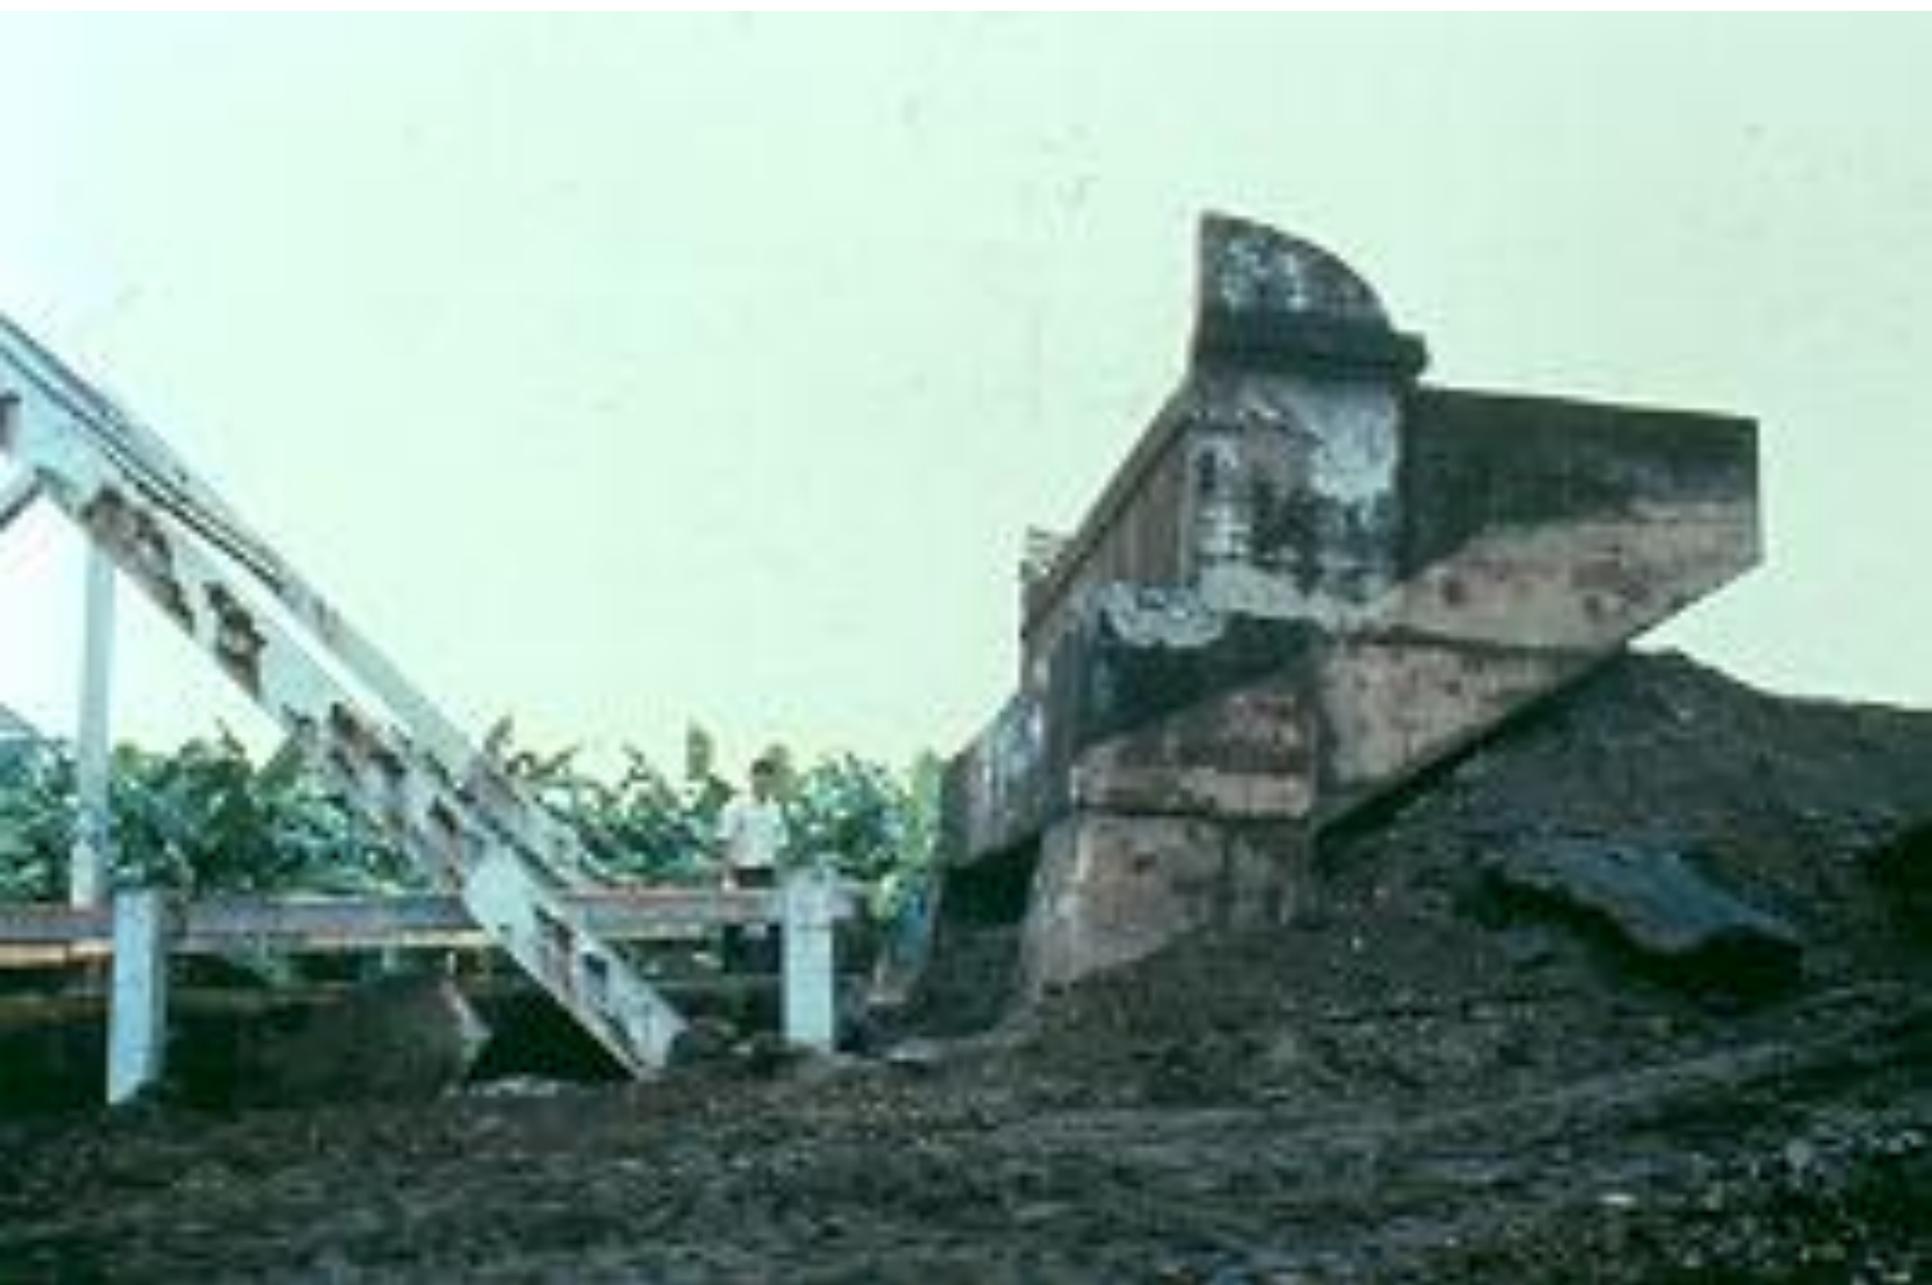
Abutment and collapsed truss of Rio Estrella highway bridge  
(University of Costa Rica photo)

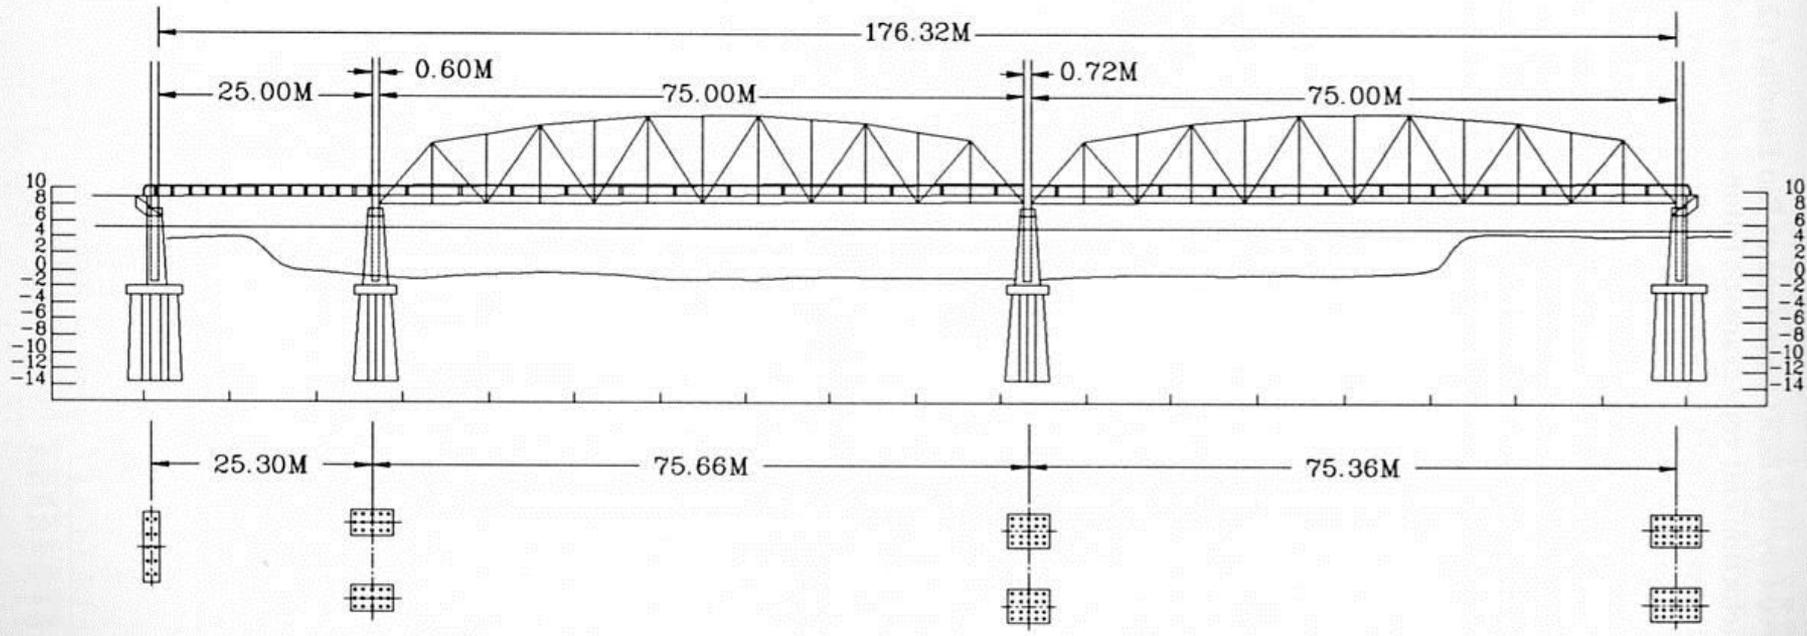
Plans for Rio Estrella highway bridge

**TABLE 6-1** Comparison of plan and measured post-earthquake distances between bridge elements for the highway bridge of Rio Estrella.

<i>Distance between center of bridge seats on</i>	<i>Plan Distance m</i>	<i>Measured post-earthquake distance m</i>
North Abutment and Pier 1	25.00	24.96
Pier 1 and Pier 2	75.00	75.02
Pier 2 and South Abutment	75.0	75.24
North and South Abutments	176.32	176.14
